# 2026 Blossom Way Groin Rehabilitation Project

## Engineer Observation Report

**Date:** 01/28/2026

Groin rehabilitation on R-108 G4 located 1,000' south of R-108.

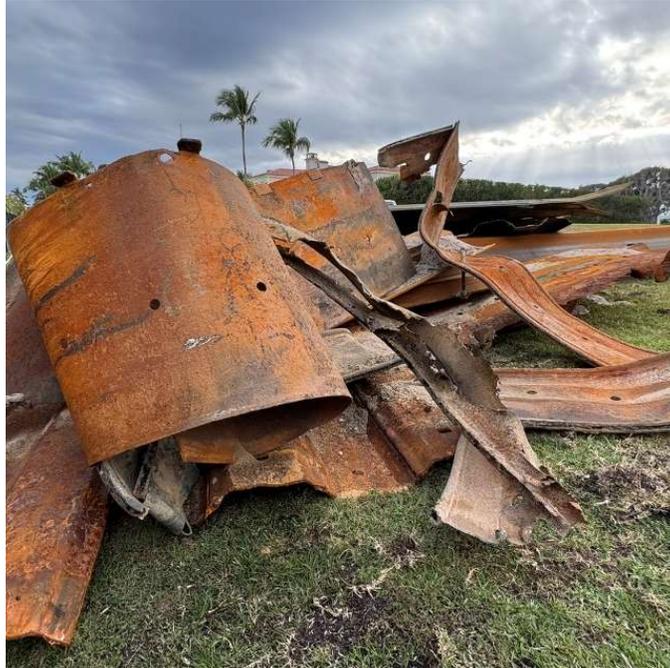
Portions of old groin removed

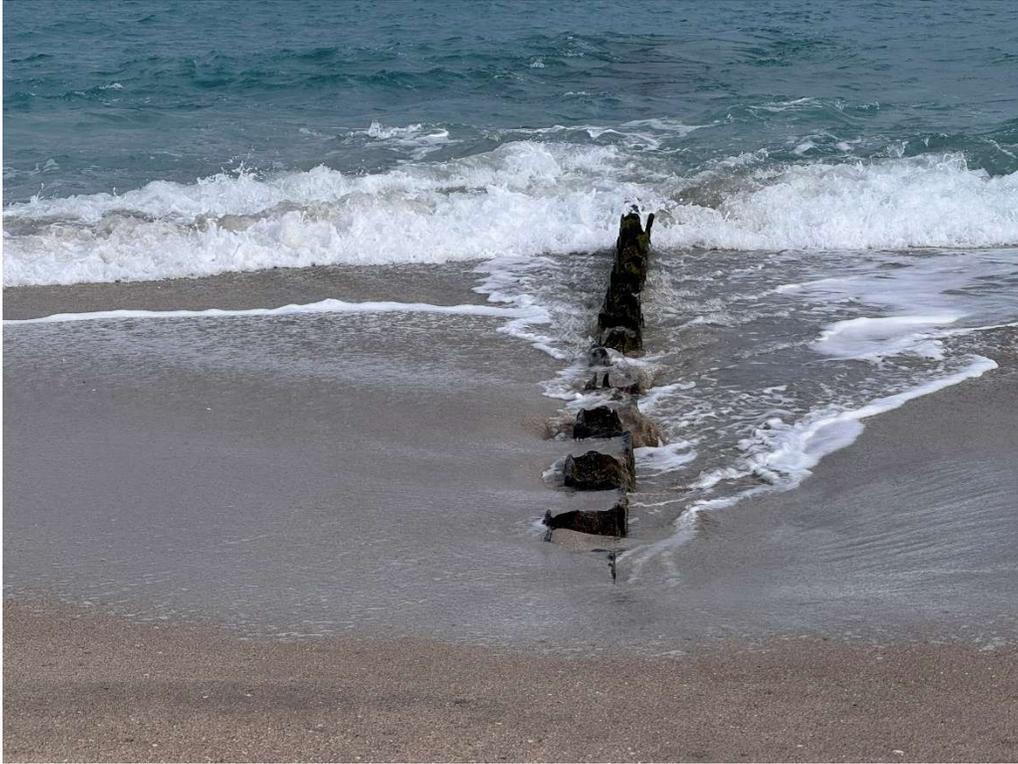
Groin C to be removed

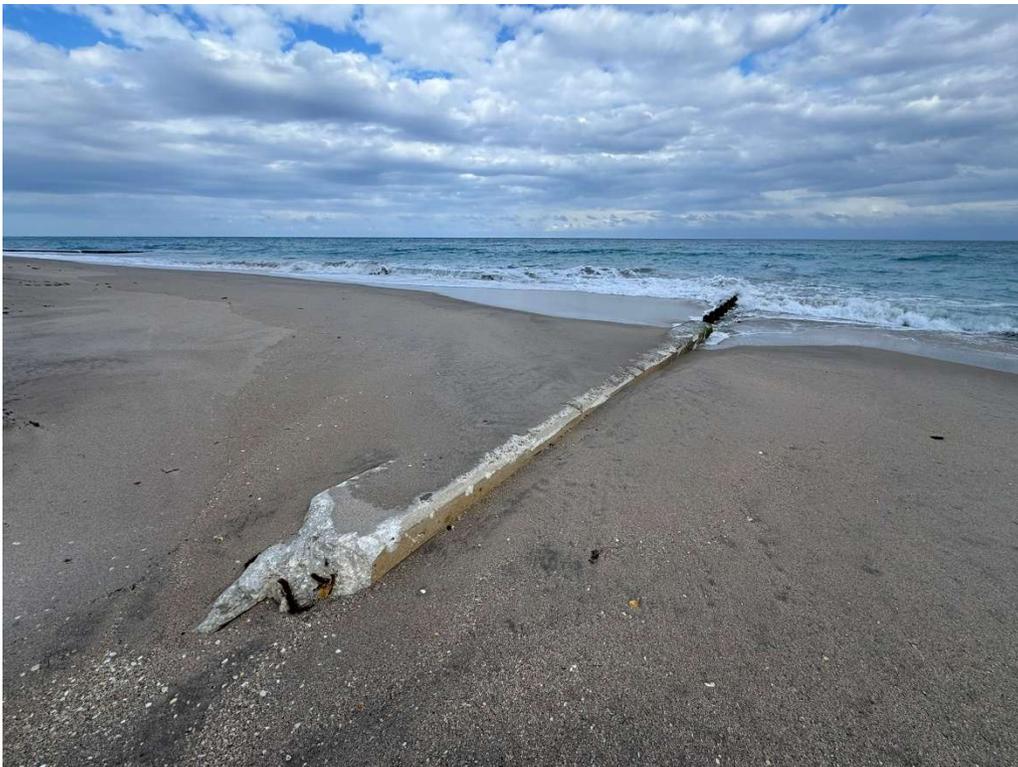
Groin B to be removed

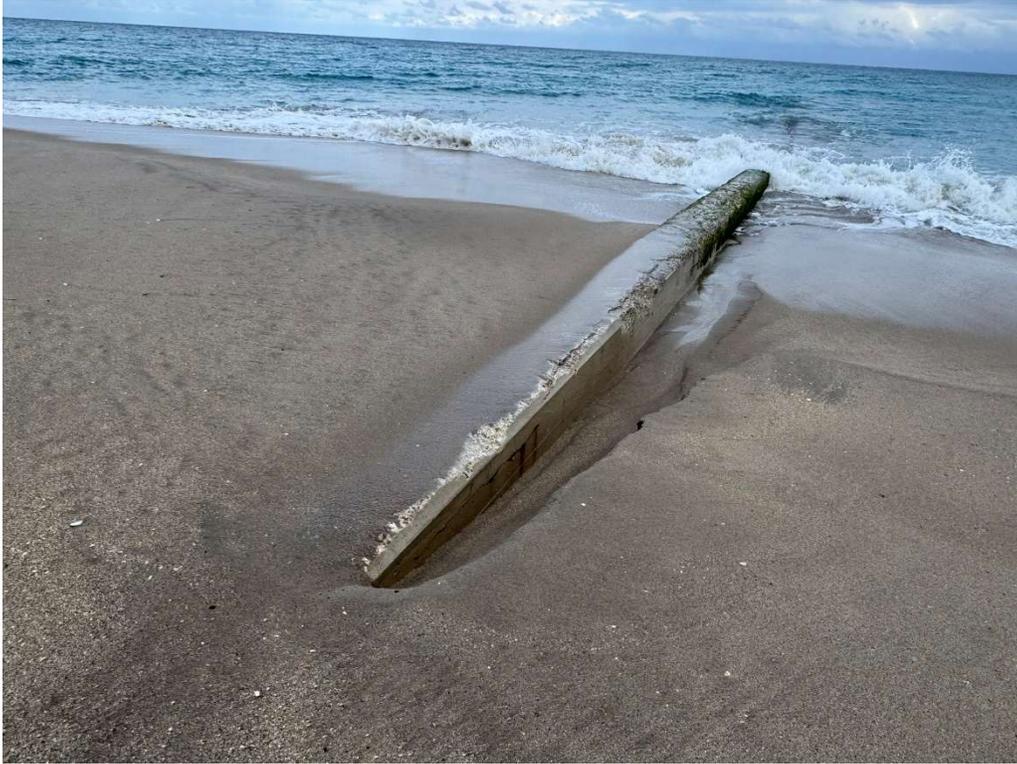
Groin A to be removed

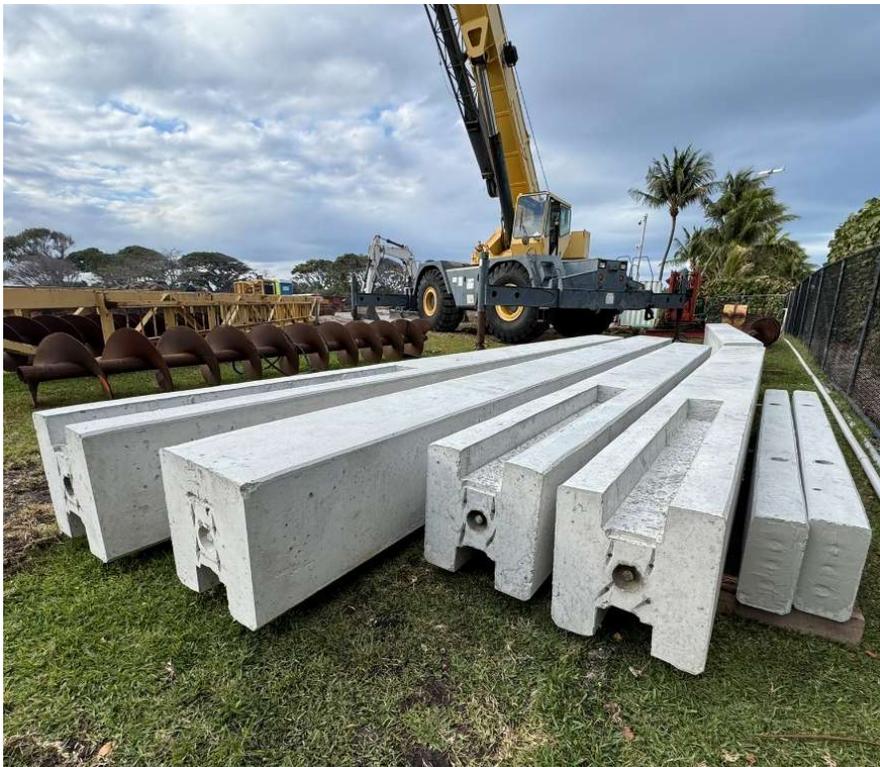
Auger and H Piles

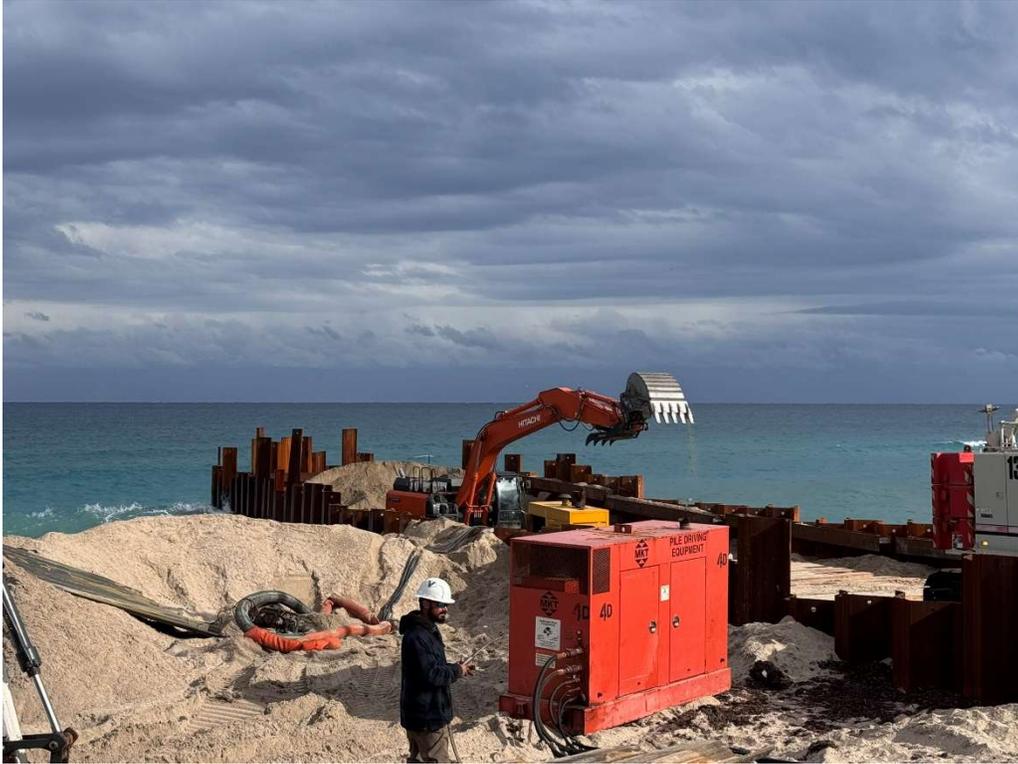
Closed off cofferdam
