2026 Blossom Way Groin Rehabilitation Project

Engineer Observation Report

Date: 02/04/2026

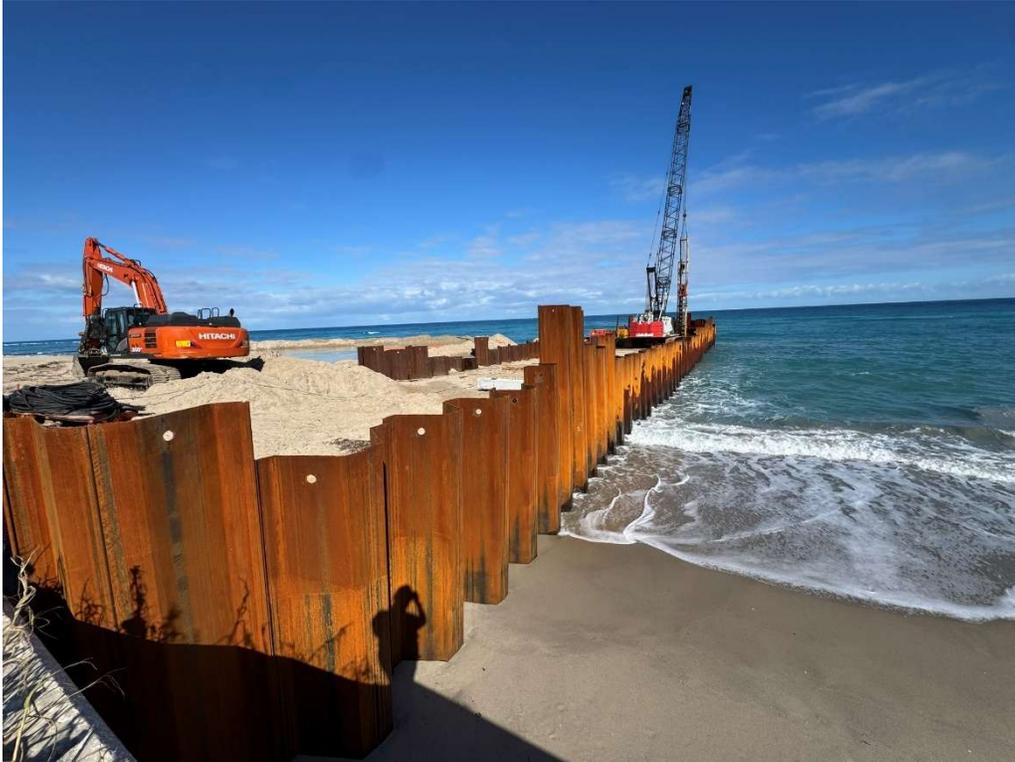
Active use of water pumps to drain cofferdam of seawater to allow crew to work and drill the holes for the H-piles. Pink line used as a template to determine where H-pile holes will be drilled.

Cofferdam looking north

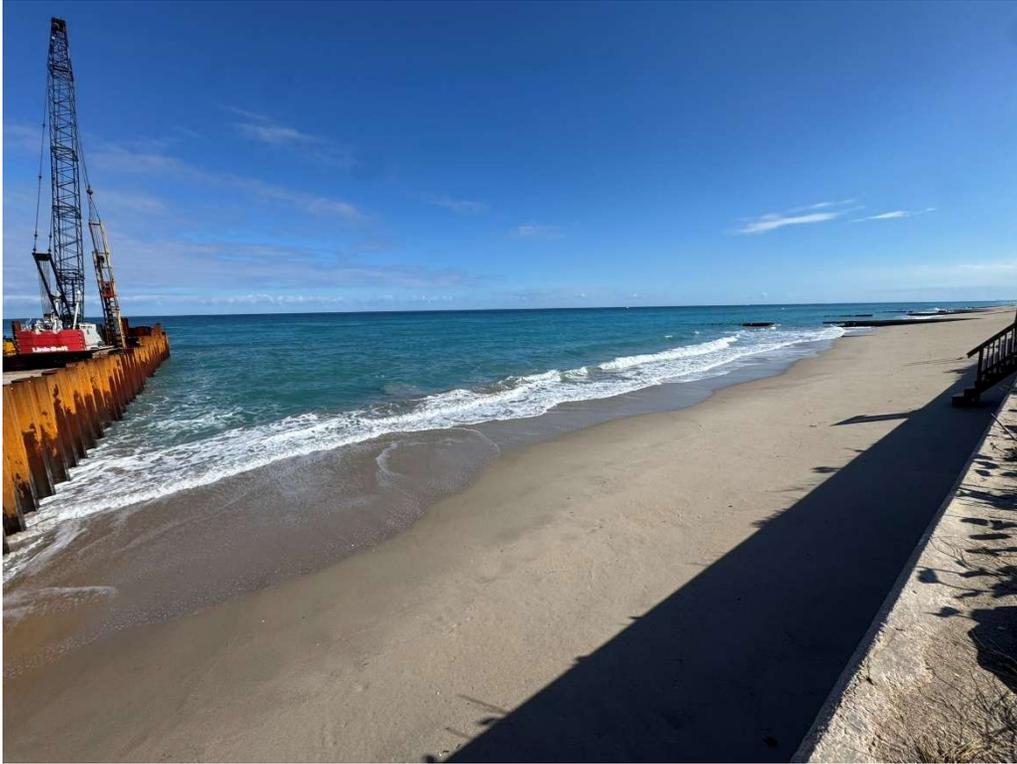
The placement of the temporary cofferdam does not show significant impact to the downdrift beach sediment flow.

Downdrift beach of cofferdam at Groin D

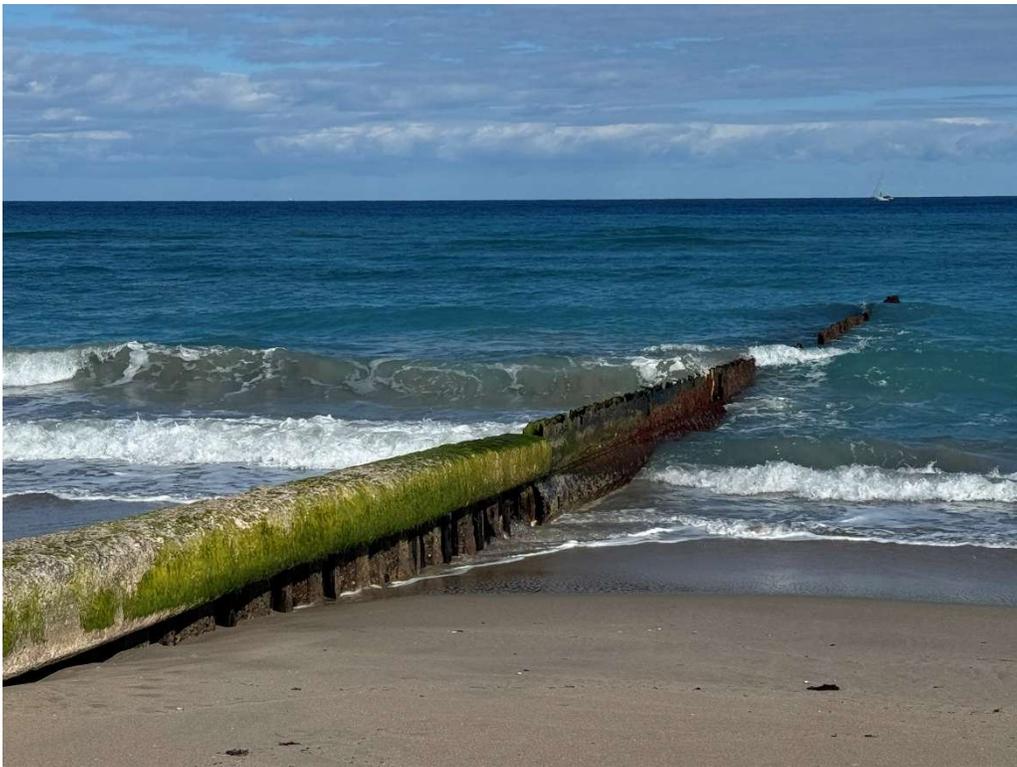
Low tide exposed most of the existing groins A, B, and C.

Exposed Groin A

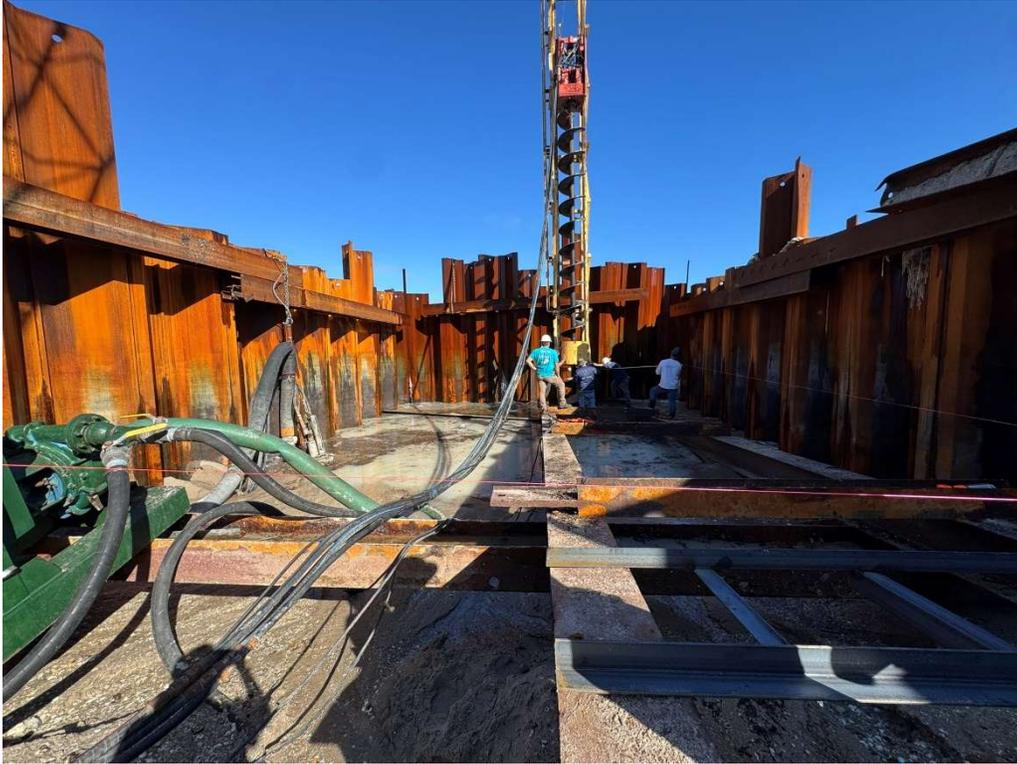
The cofferdam has been completed and crew is actively using auger to drill into sand/rock to prepare holes for the new groin H-piles. 19 total H-piles will be used for Groin D and crew started placing H-piles 16 to 19 (furthest H-piles east). Crew actively measuring accuracy of drill location to ensure that all H-piles will line up.

Drilling for placement of H-pile 19

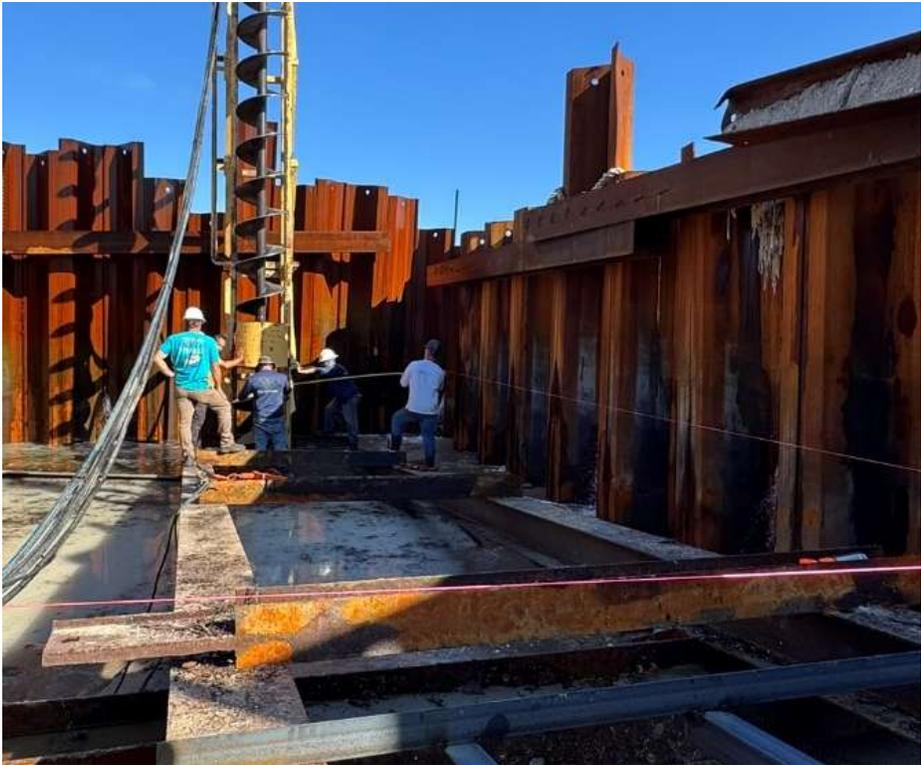
Pink template to measure placement of hole
