2026 Blossom Way Groin Rehabilitation Project

Engineer Observation Report

Date: 01/22/2026

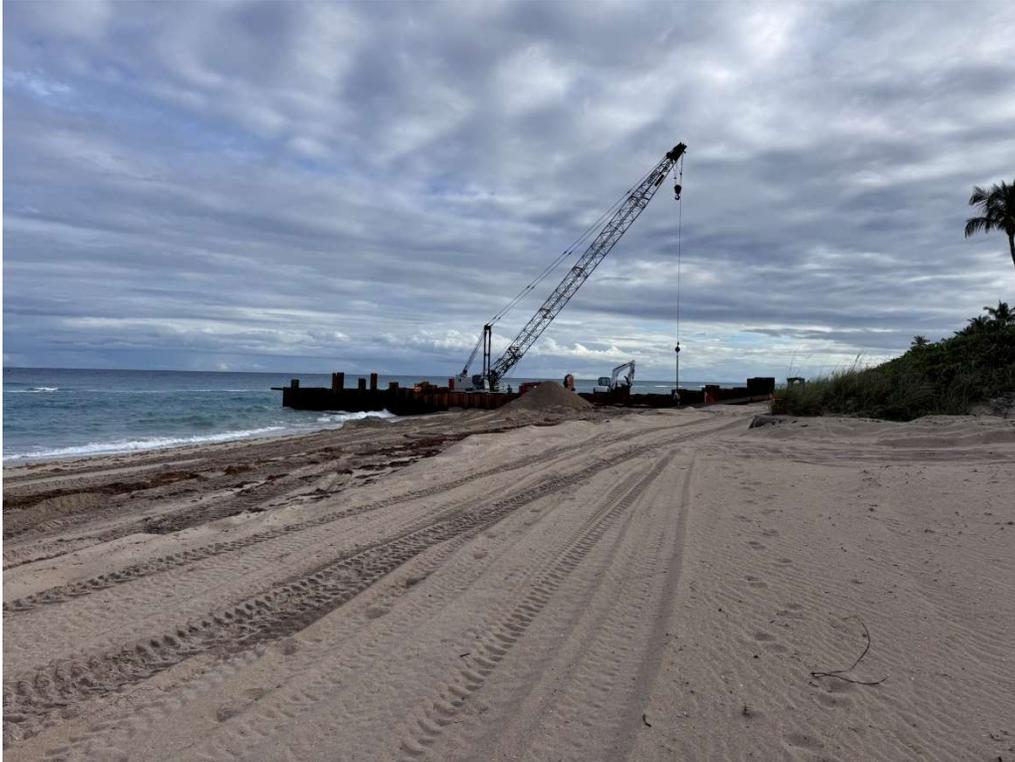
Groin D construction progress

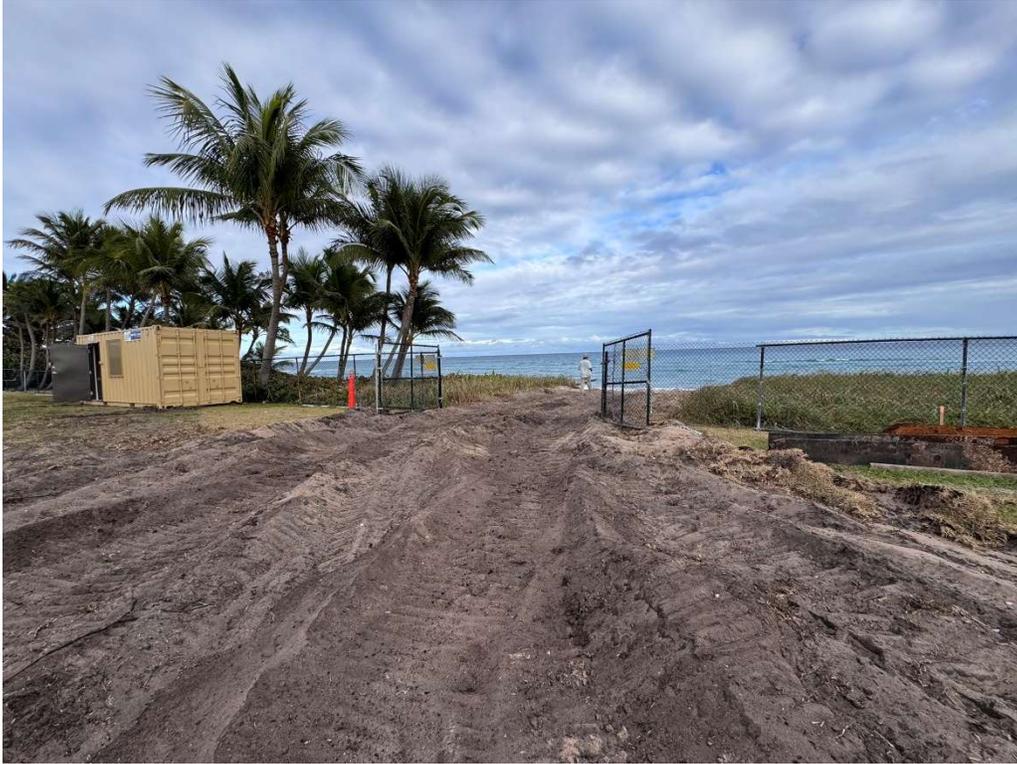
Beach access for equipment

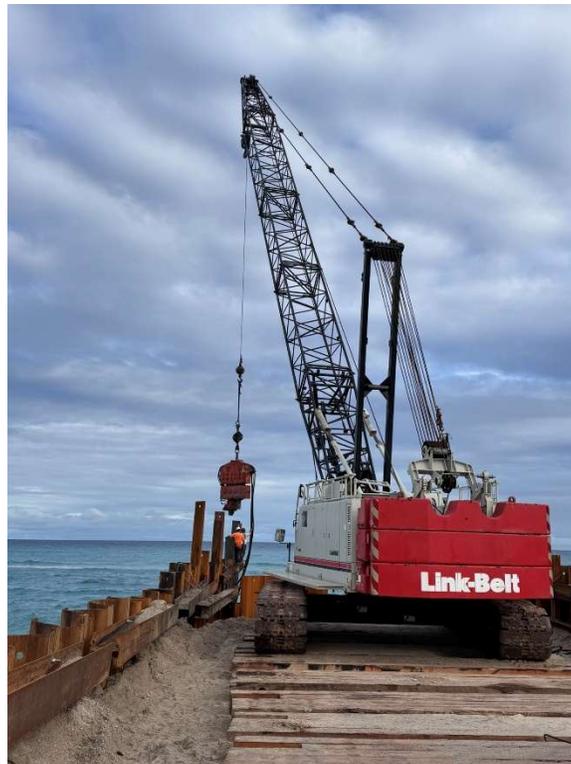
Crane pile driver used to set panels in place

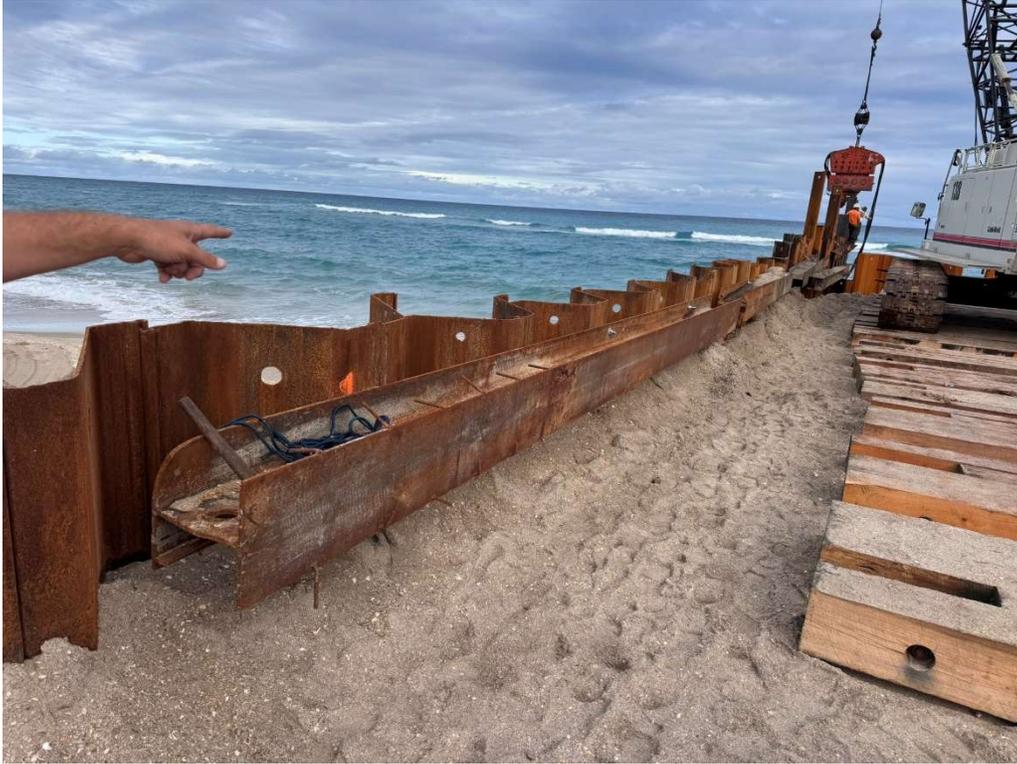
Walers bolted onto panels along left side of groin

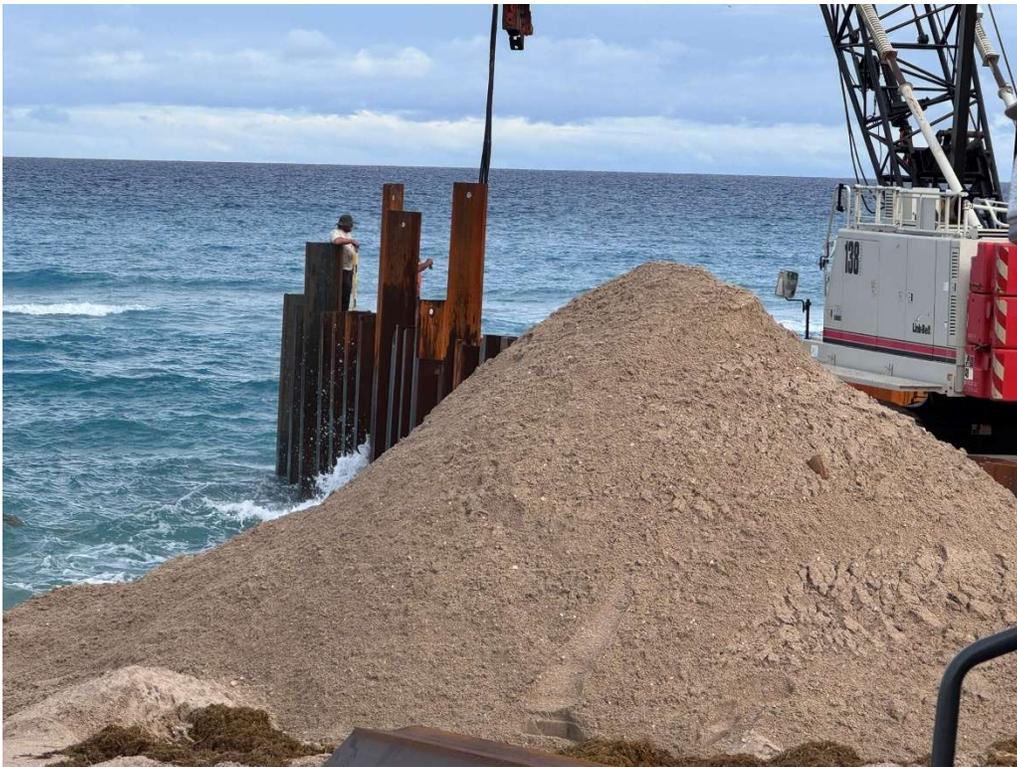
Sand pile used to fill in groin as they move seaward

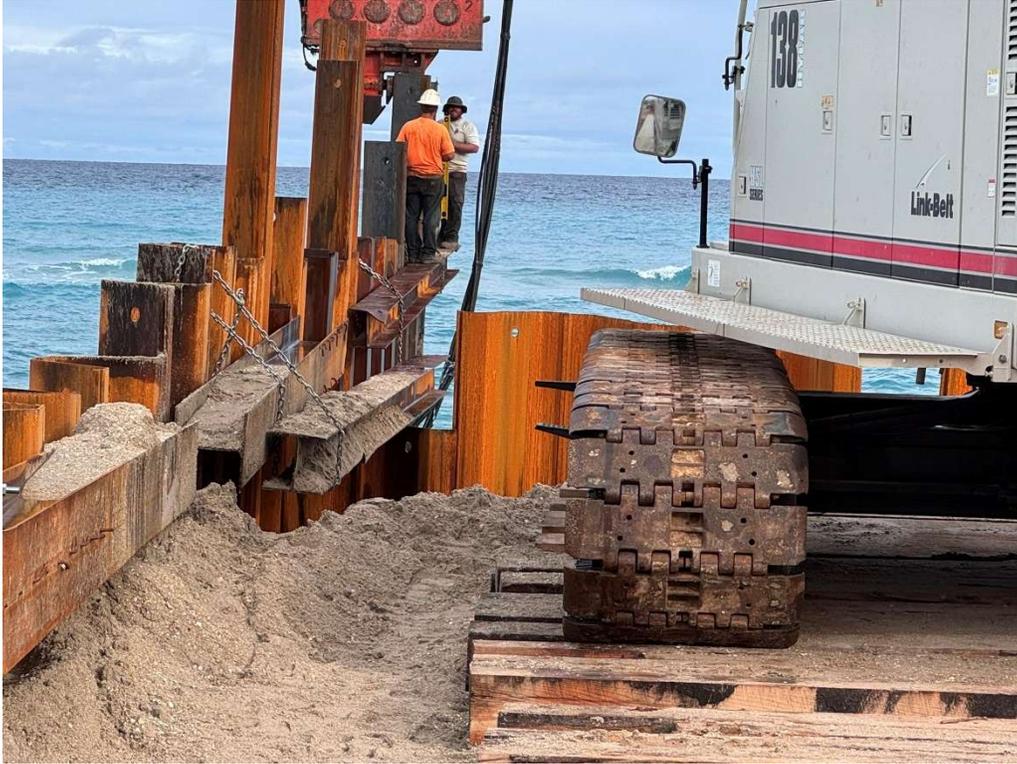
Barrier to keep sand in place

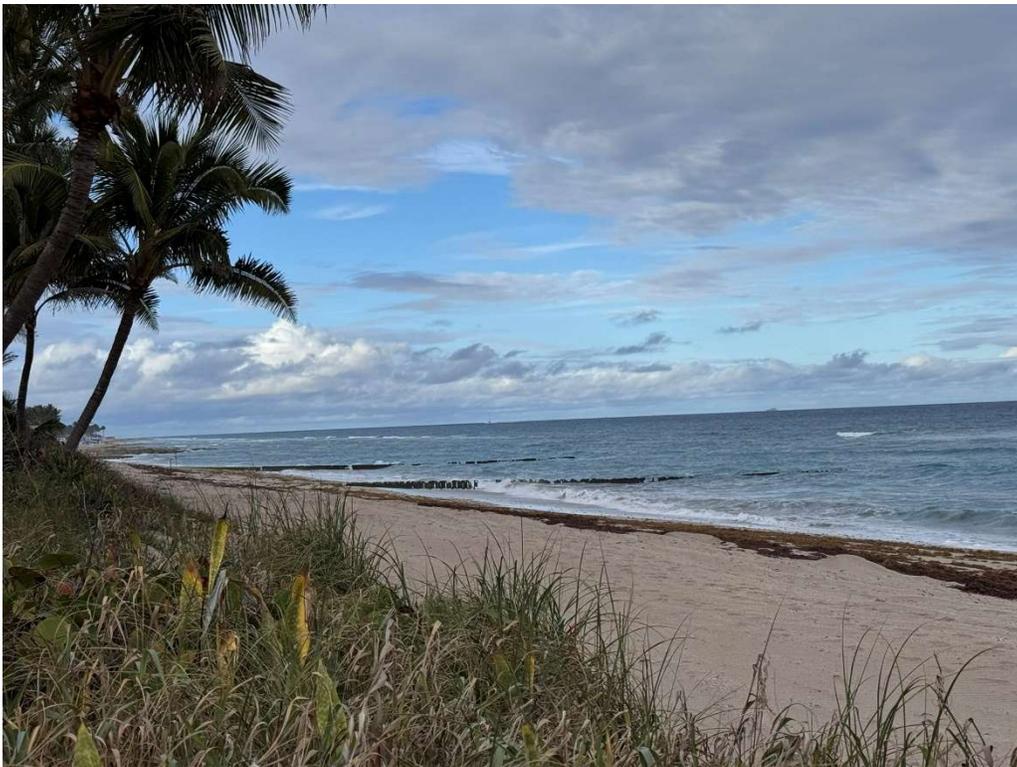
Existing conditions of Groins A thru C
