# 2026 Blossom Way Groin Rehabilitation Project

## Engineer Observation Report

**Date:** 02/11/2026

Groin rehabilitation on R-108 G4 located 1,000' south of R-108.

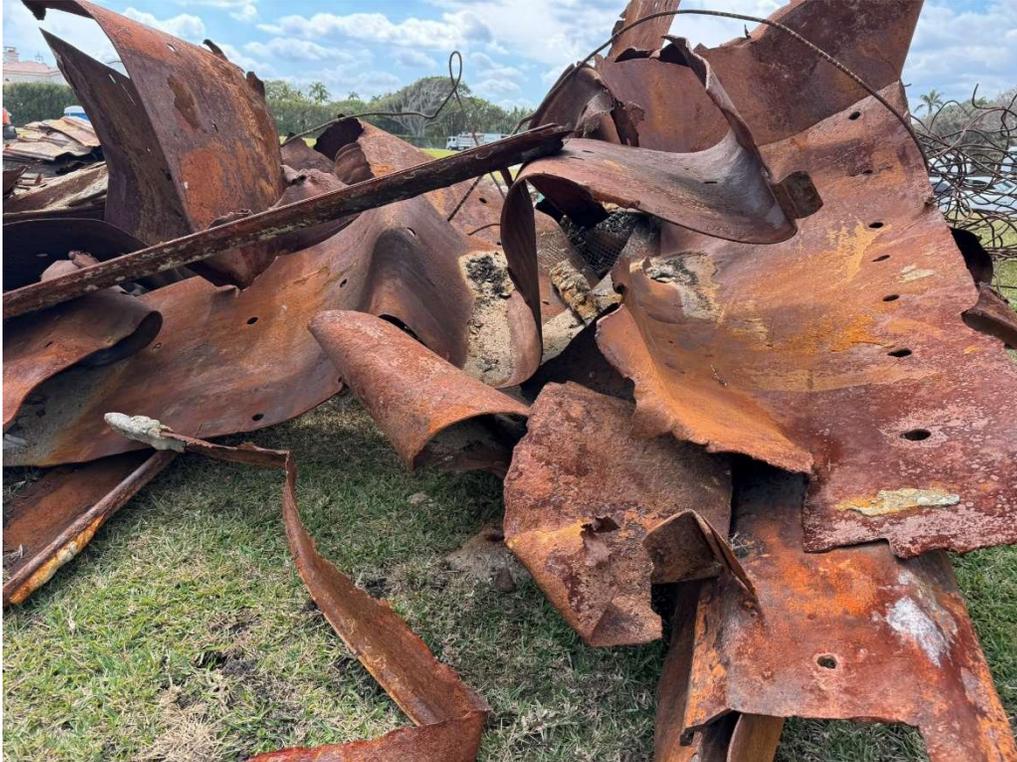
Old groin removed and stored off beach

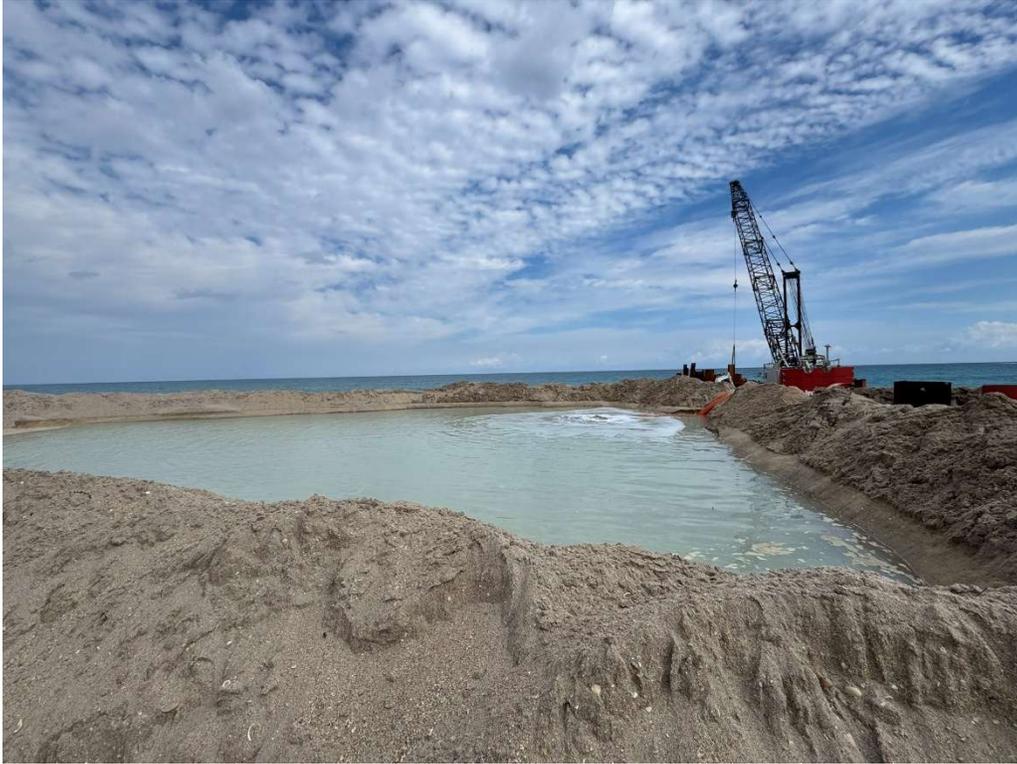
Active use of water pumps to drain cofferdam of seawater to allow crew to work and place the H-piles in place.

Output of water pump within cofferdam

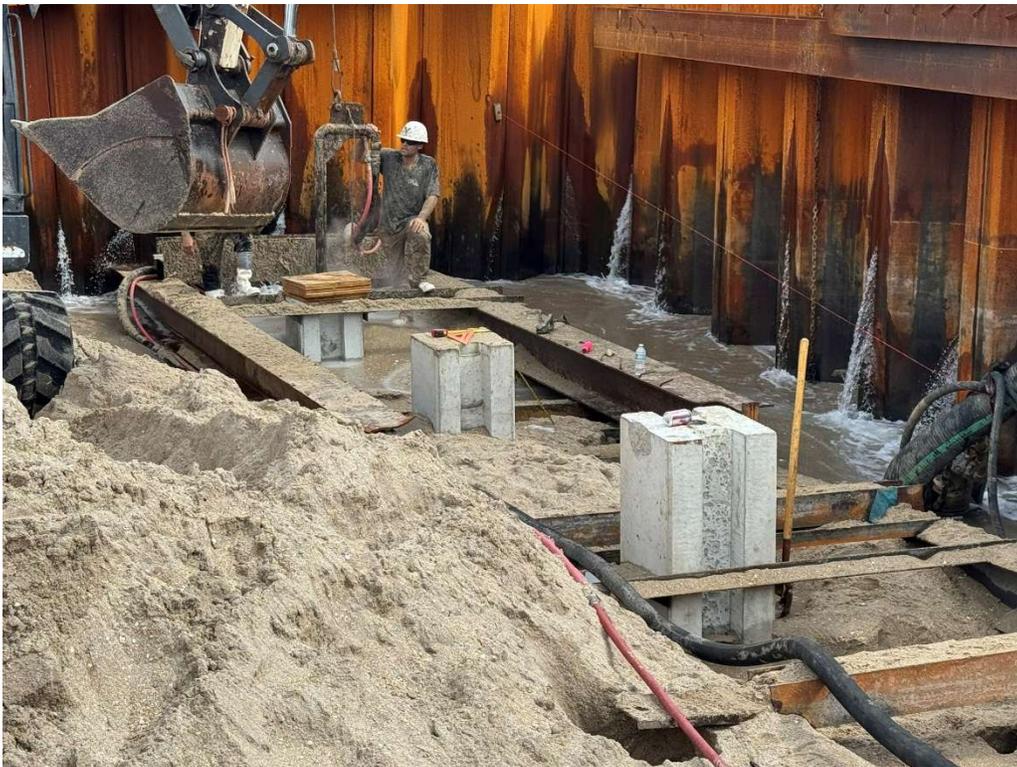
Piles 16, 17, 18, and 19 have been placed in their respective locations and are to be pushed to their elevation once a second water and air jet set up to make it easier for the piles to slide into place.

H-Piles in place to be slid further down in elevation

Spoke to Whitmore Benoit (Vance Project Manager) on site and updated me on the status of the groin rehabilitation. He told me that they are working on finishing the implementation of H-piles 16, 17, 18, and 19. They will be setting up a second water and air jet to apply on each side of the H-pile to allow the pile to slide into place easier.

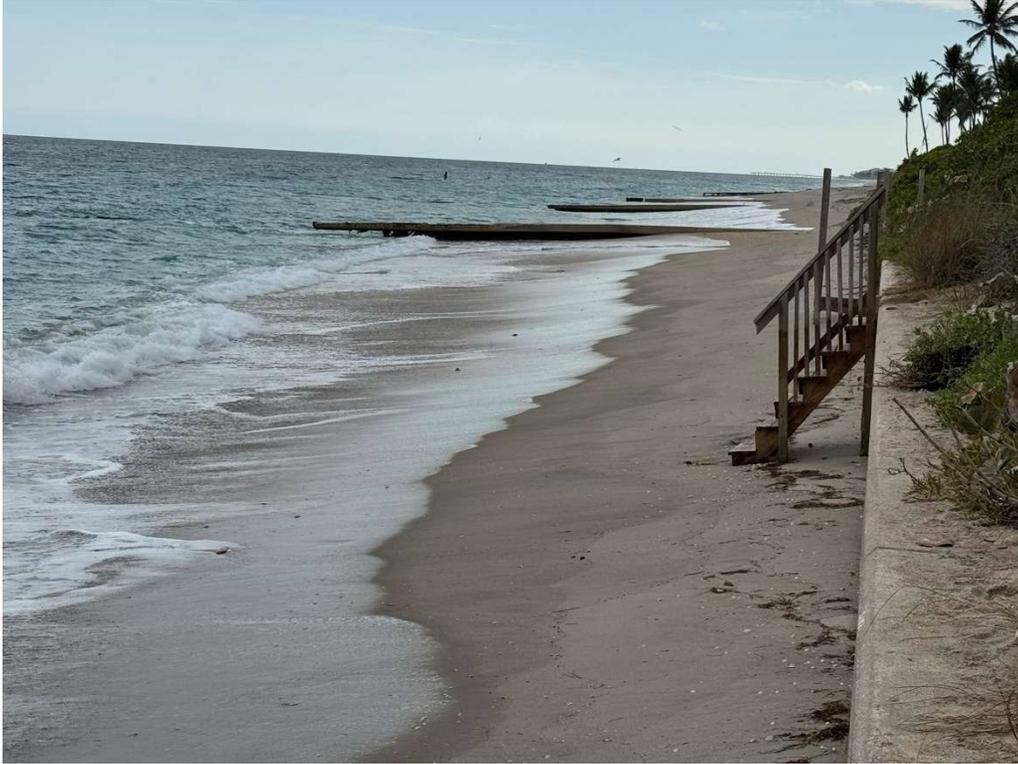
The placement of the temporary cofferdam shows a slight interruption in downdrift sediment transport based on the downdrift property stairs. Depending on the tide, the height of the beach reaches the second or third stair from the bottom.

Downdrift property and stairs baseline

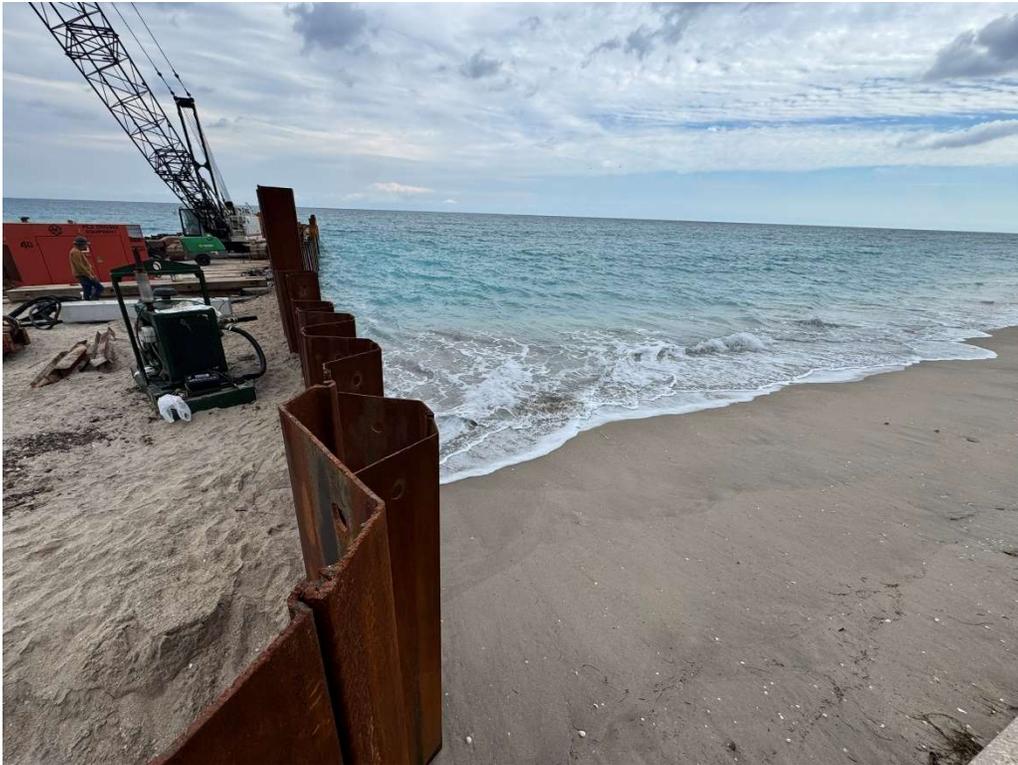
Contrasting of beach elevation between cofferdam and downdrift property
