2026 Blossom Way Groin Rehabilitation Project

Engineer Observation Report

Date: 02/26/2026

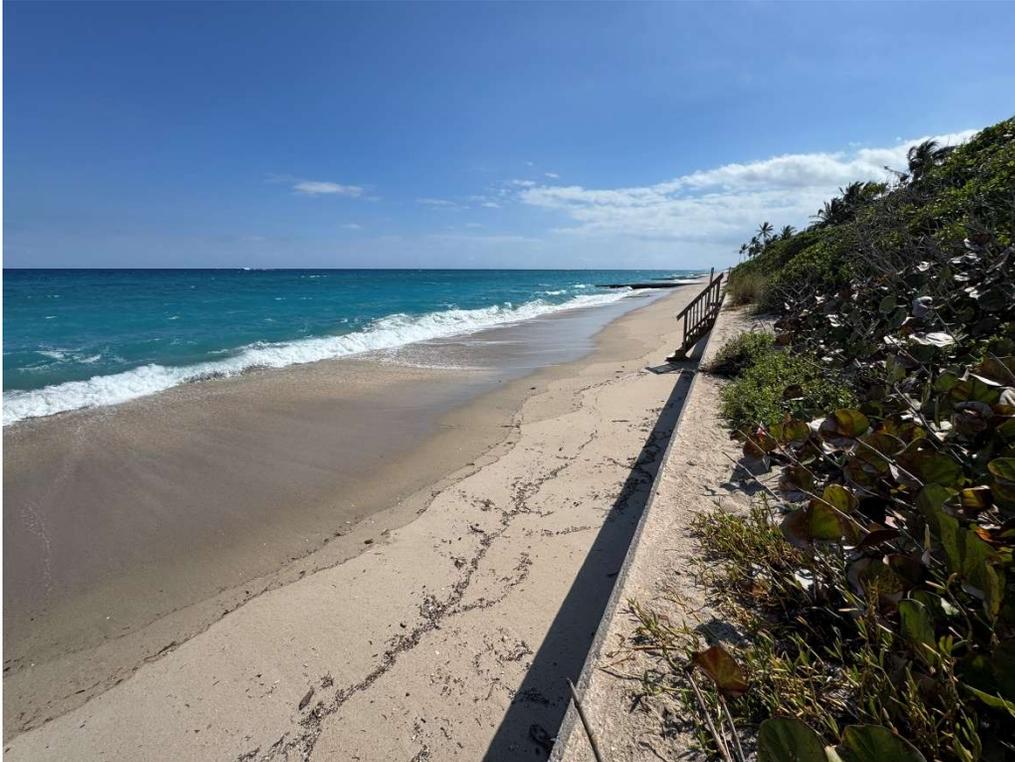
The downdrift beach continues to maintain a steady shoreline despite the temporary cofferdam disrupting sediment flow.

Downdrift property shoreline

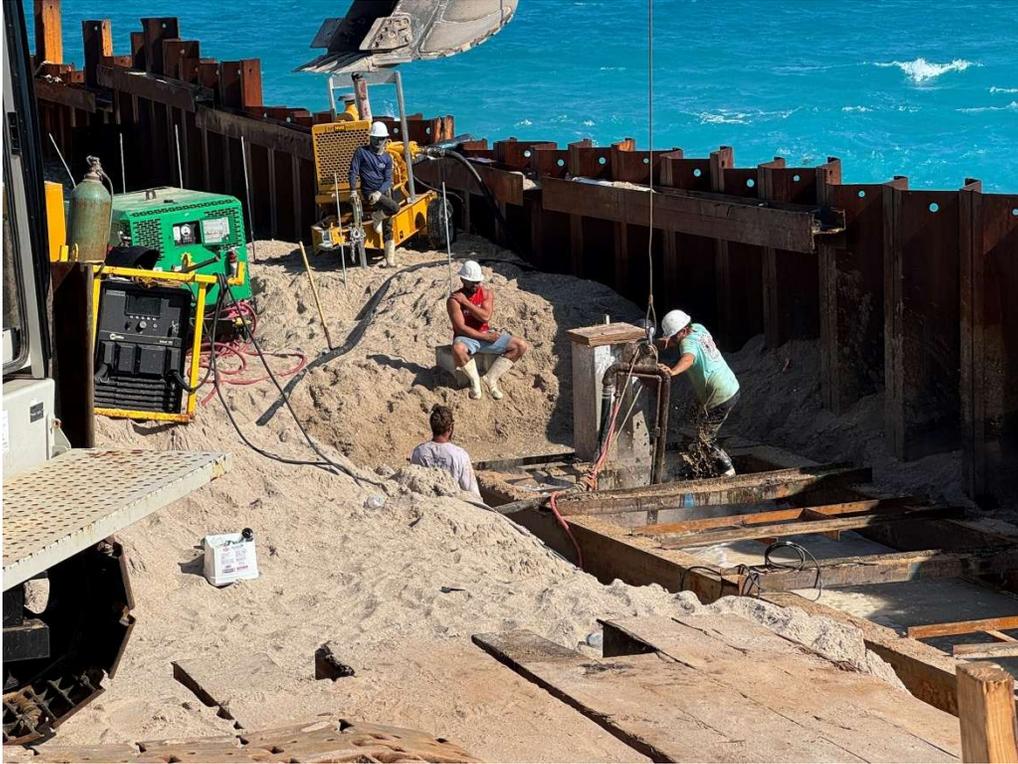
Crew uses an excavator to apply pressure at the top of the H-piles to help ease it into the augered hole and it has been a great benefit. Almost all the old groin has been taken offsite to a proper disposal center.

Implementation of D7

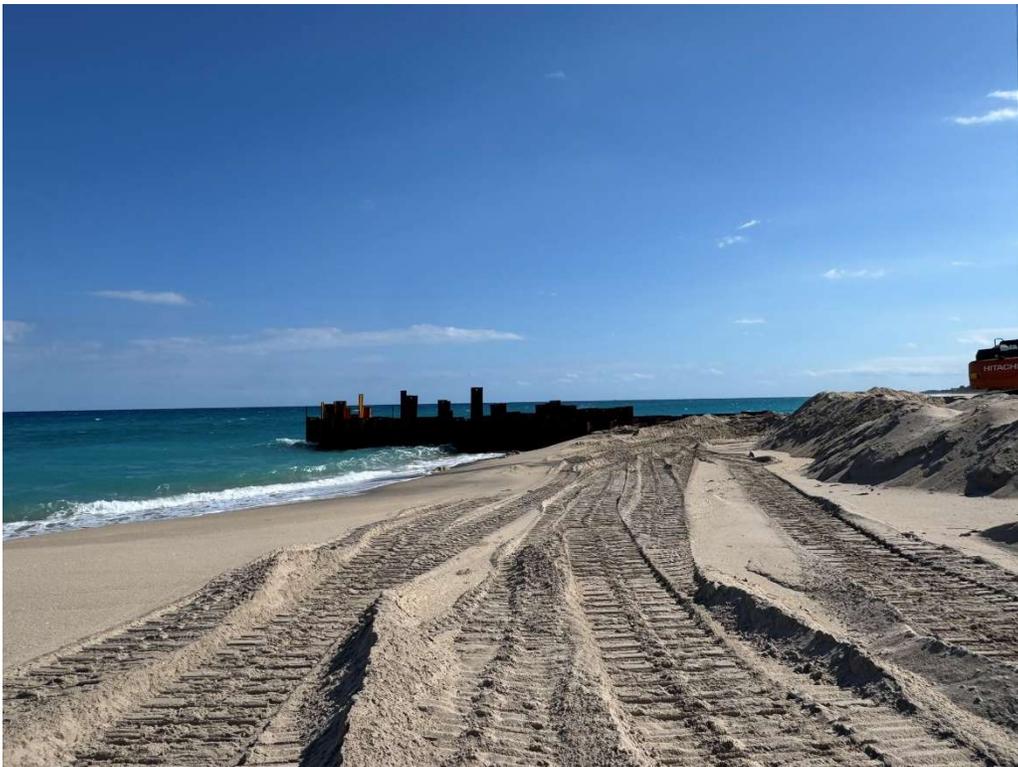
North property shoreline

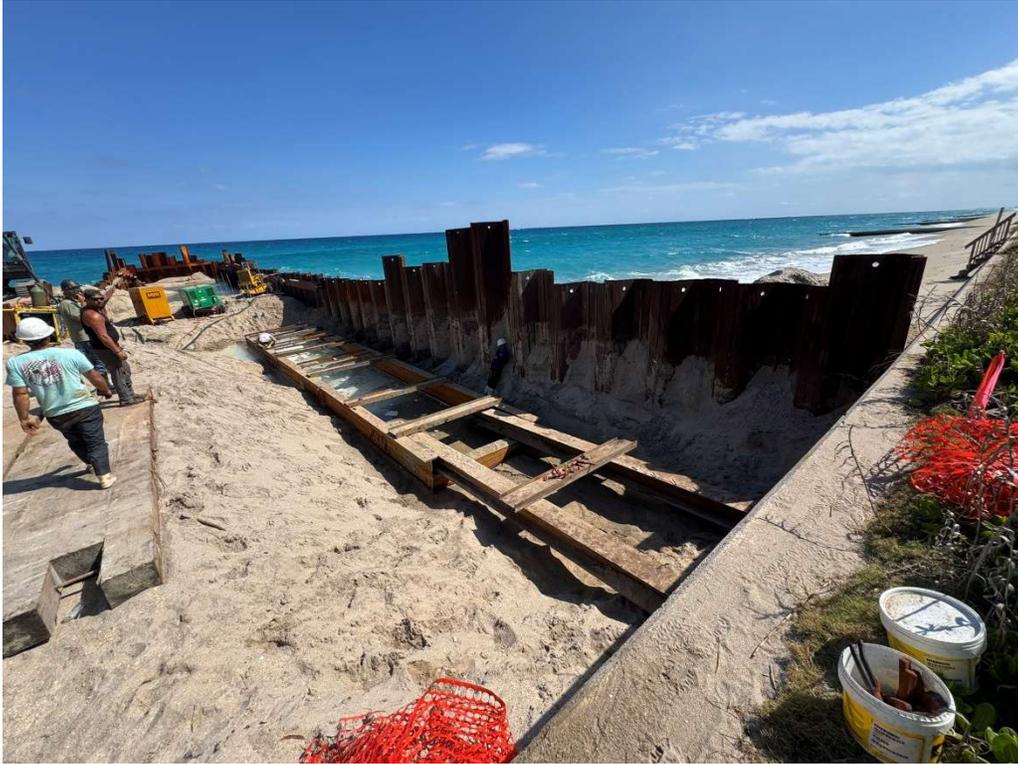
Jetted D8 - D11 further down to respective elevation. Template for D7 – D1 setup for augering and H-piles.

Template for D7 – D1

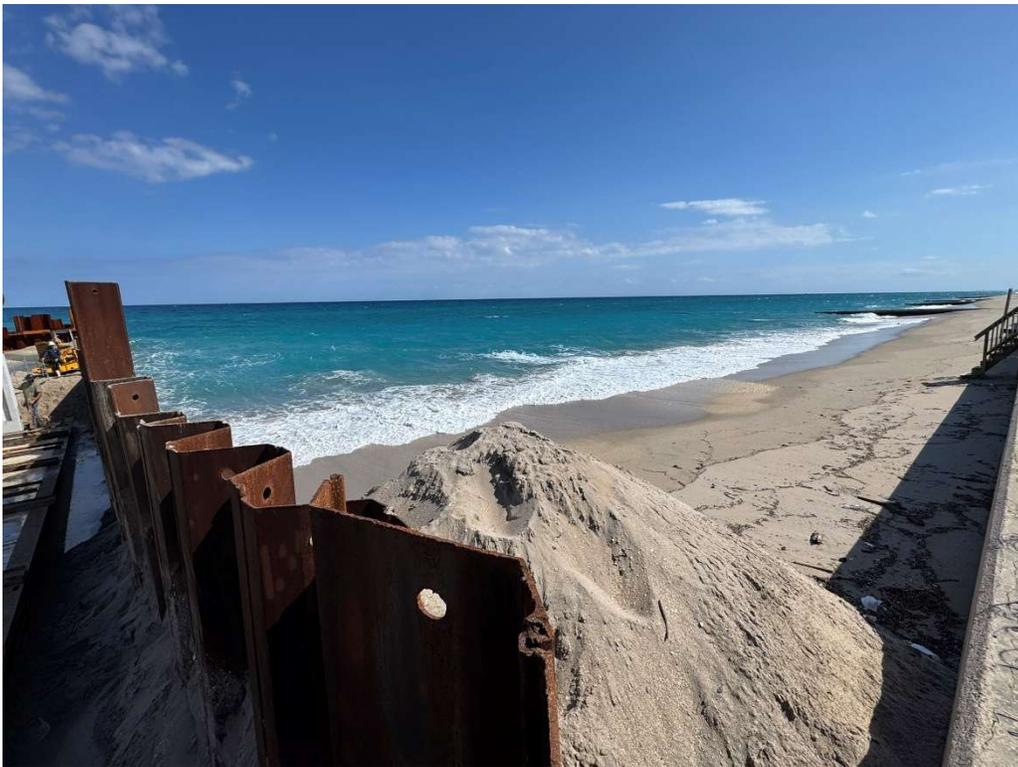
Sand pile for future use

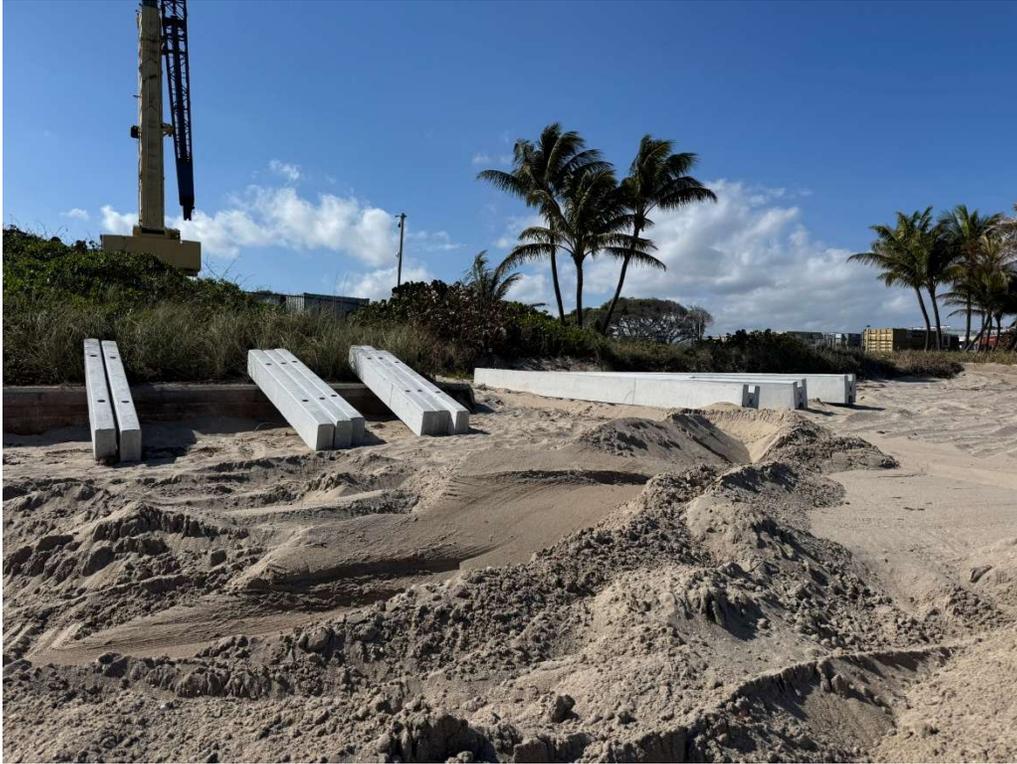
H-piles for future use

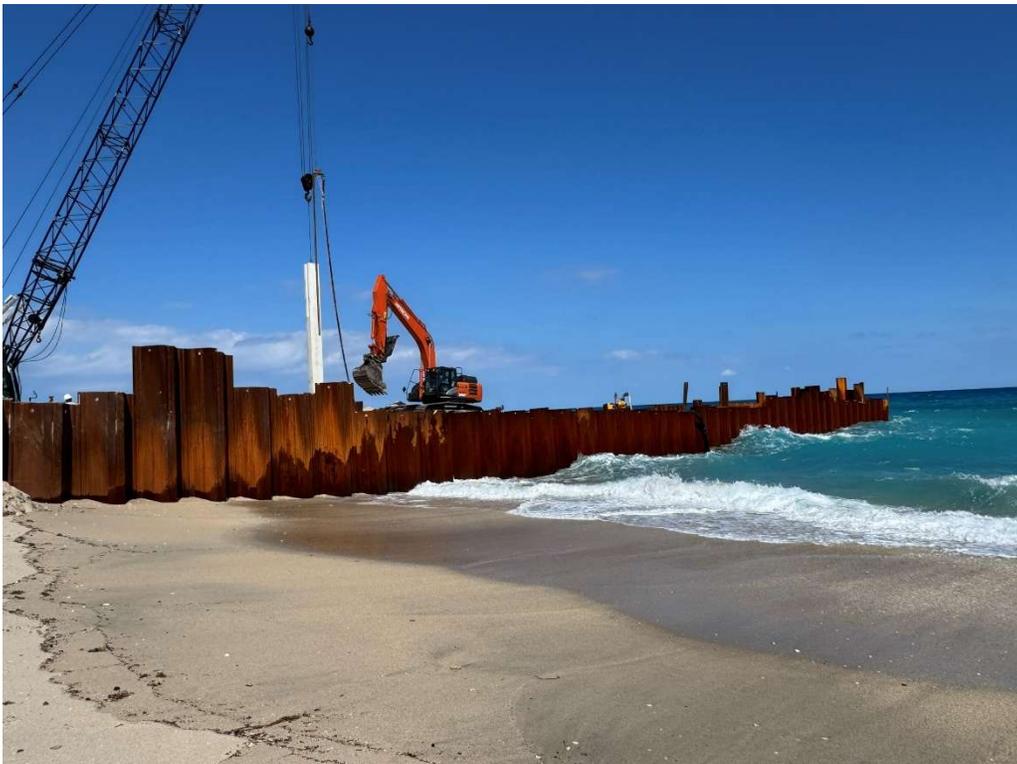
Full cofferdam looking North
