2026 Blossom Way Groin Rehabilitation Project

Engineer Observation Report

Date: 02/18/2026

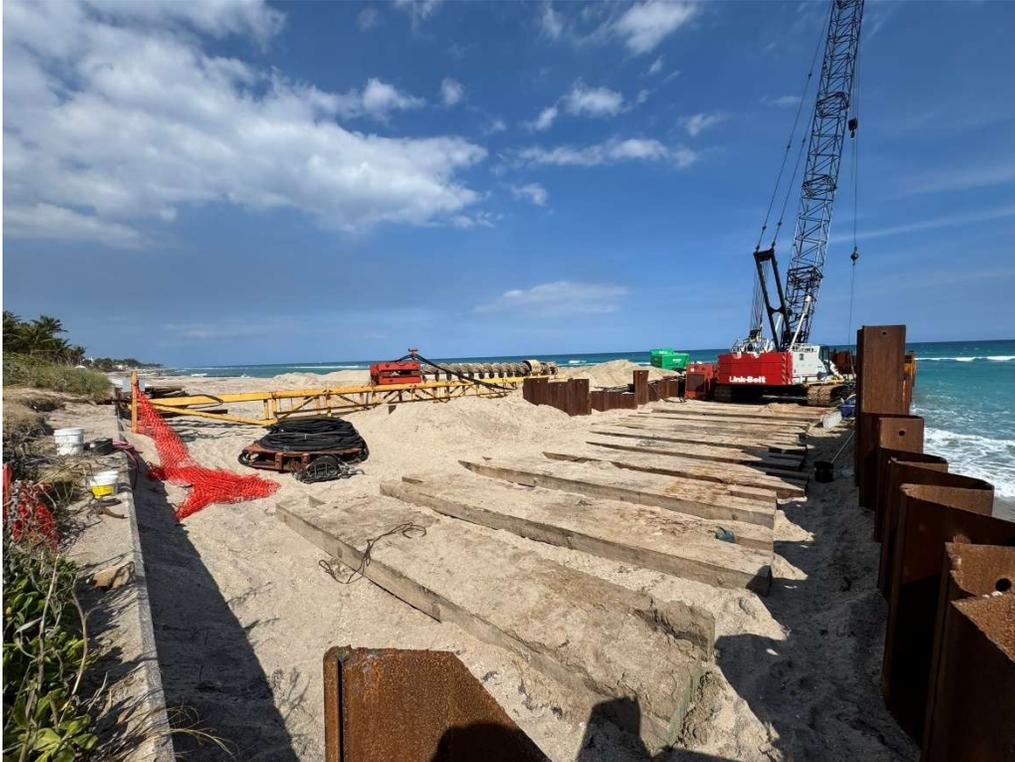
Overall cofferdam of Groin D

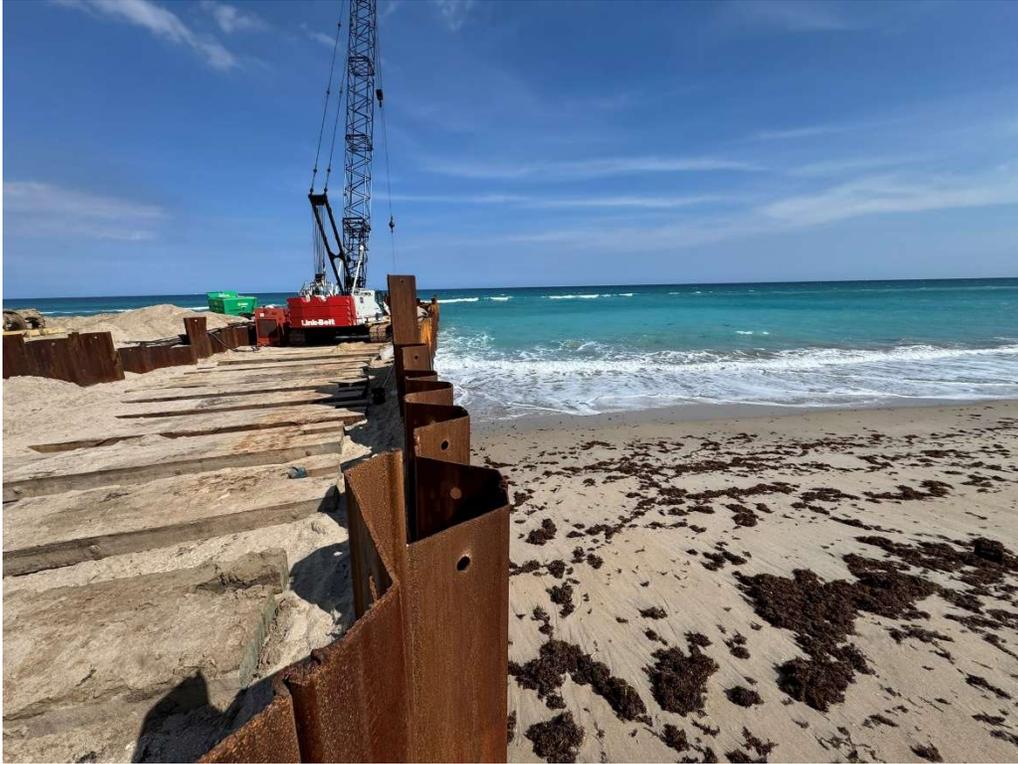
Jetted D16 - D19 further down to respective elevation. Setting up the template for D15 – D12. The downdrift beach continues to maintain a steady shoreline despite the temporary cofferdam disrupting sediment flow. The beach stairs of the neighboring property serve as a guide for the change in sand volume. The beach continues to reach up to the first step of the stairs which indicates that the cofferdam and groin rehabilitation is not causing a harmful effect to downdrift properties.

Downdrift beach comparison

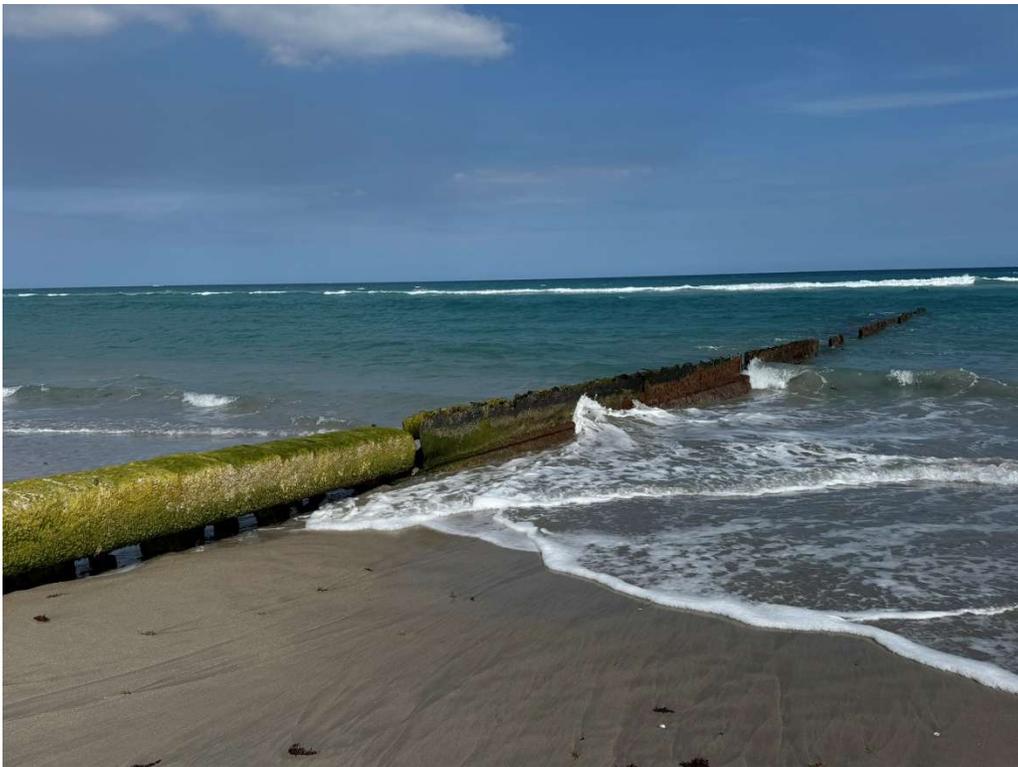
Exposed Groin A

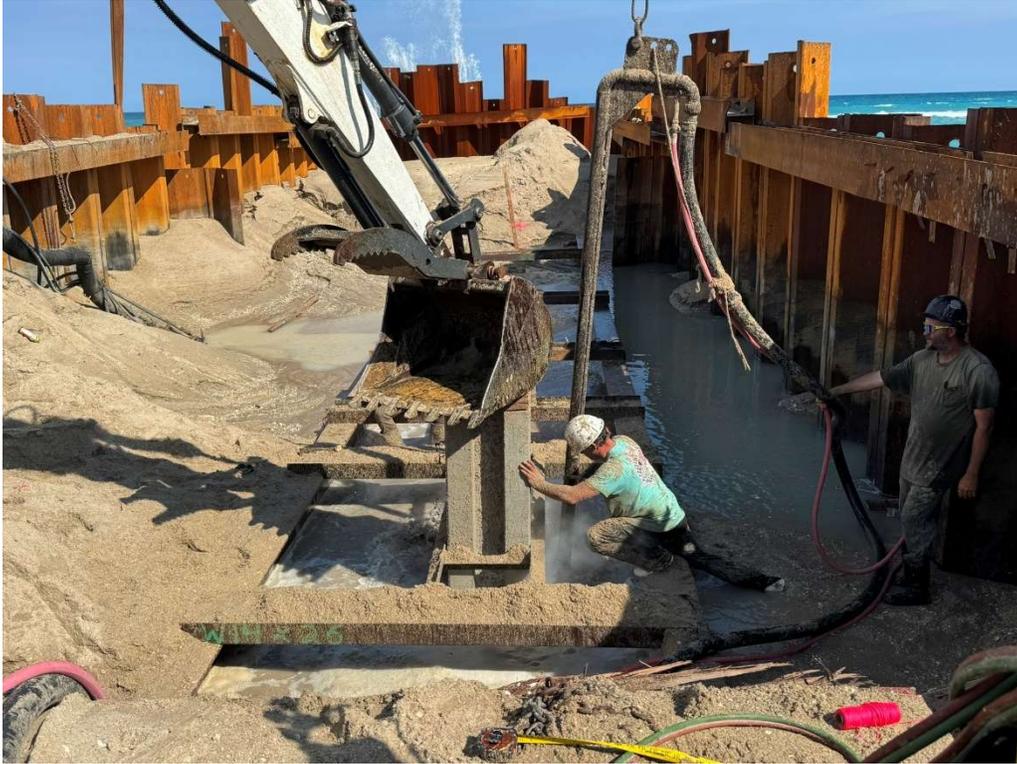
Crew has started to use an excavator to apply pressure at the top of the H-piles to help ease it into the augered hole. Another excavator has begun to fill up a dumpster for the old groin to be hauled away and properly disposed. The next set of H-piles on site and ready to be installed.

Use of excavator to push H-pile
