2026 Blossom Way Groin Rehabilitation Project

Engineer Observation Report

Date: 03/12/2026

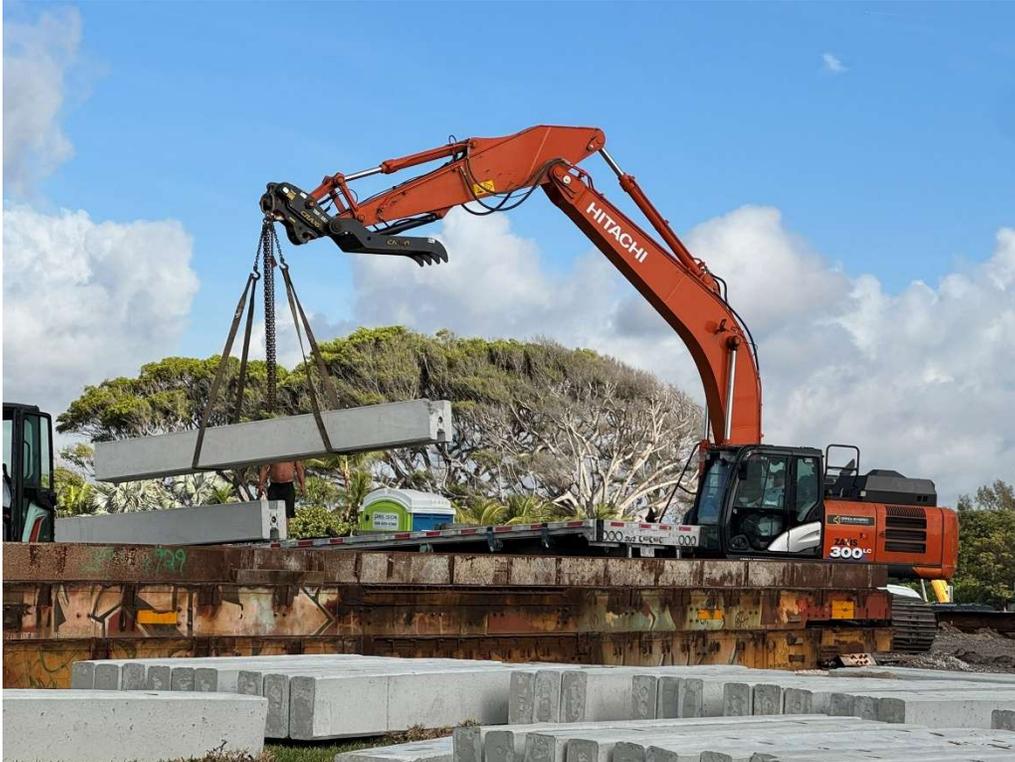
Delivery of H-Piles

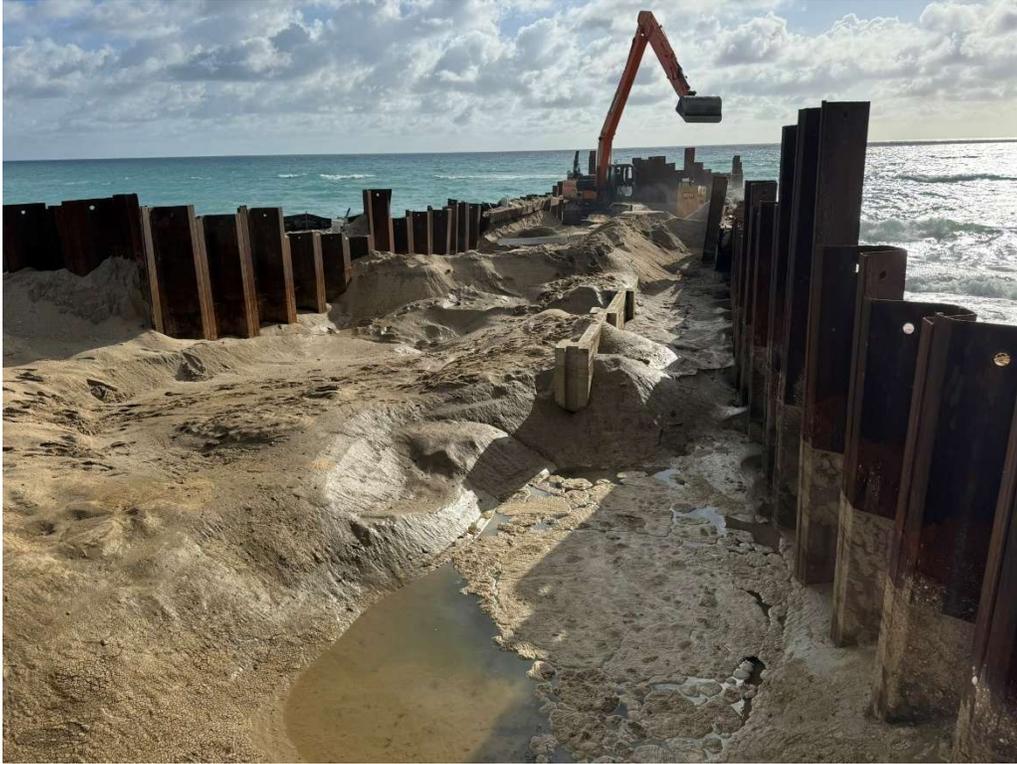
Current conditions of Groin D

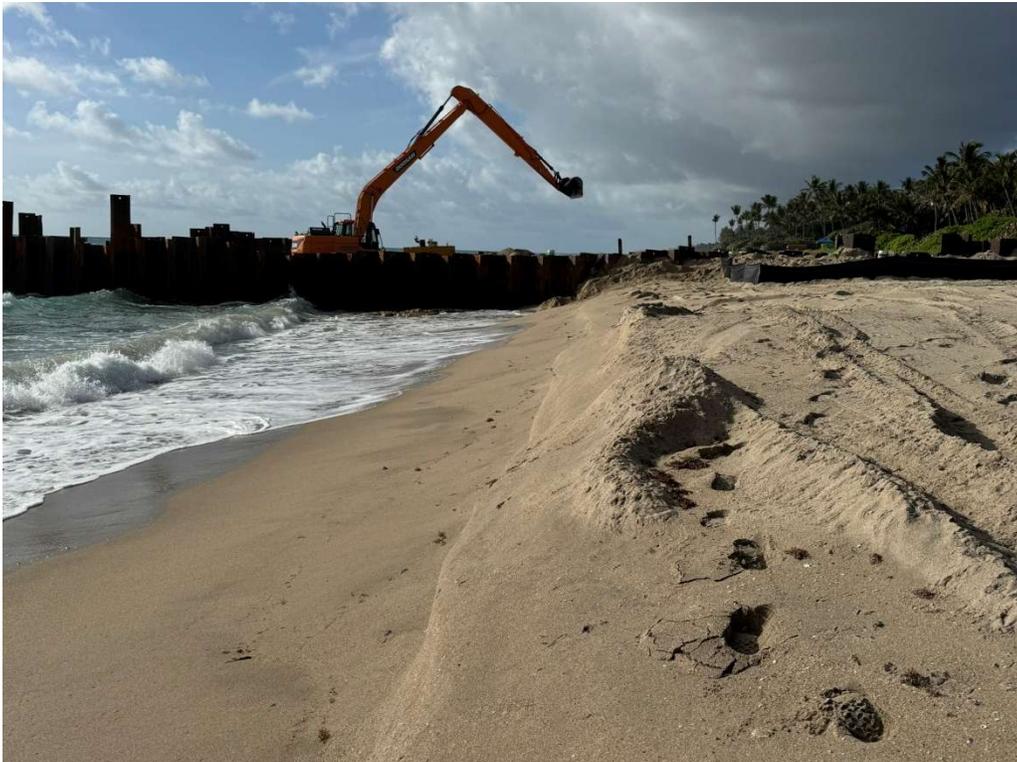
Slight escarpment forming north of Groin D

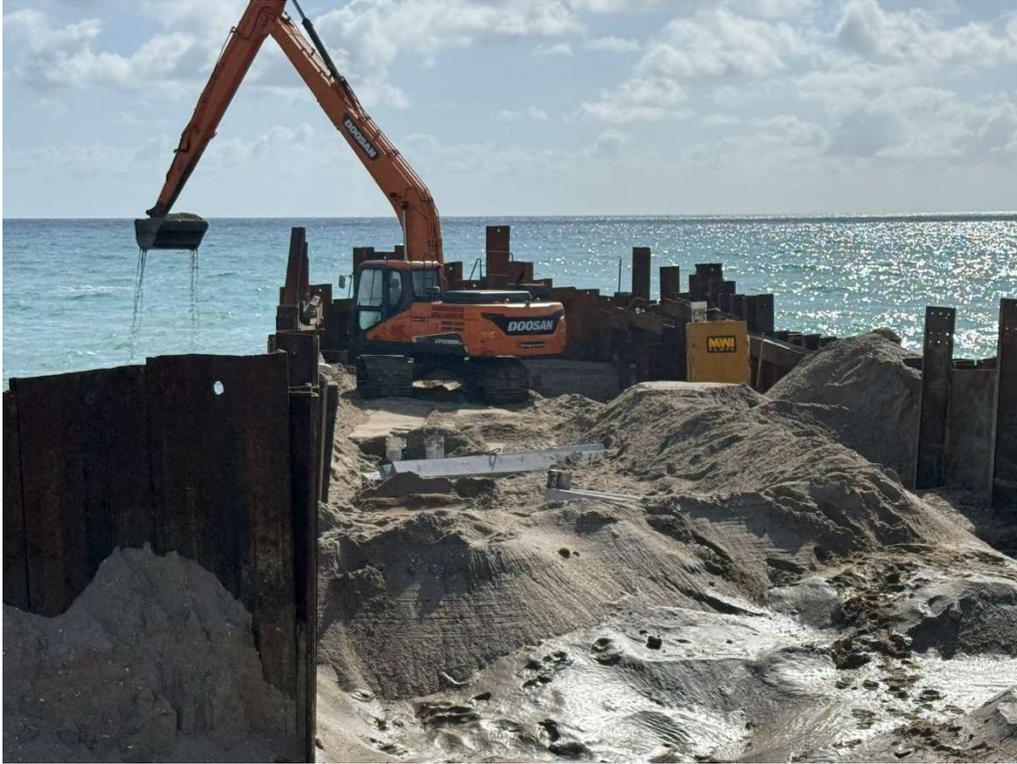
Crew has started augering holes for Groin A's H-piles while and excavator being used to fill in cofferdam at Groin D with sand for future breakdown.

Excavator filling in cofferdam with sand

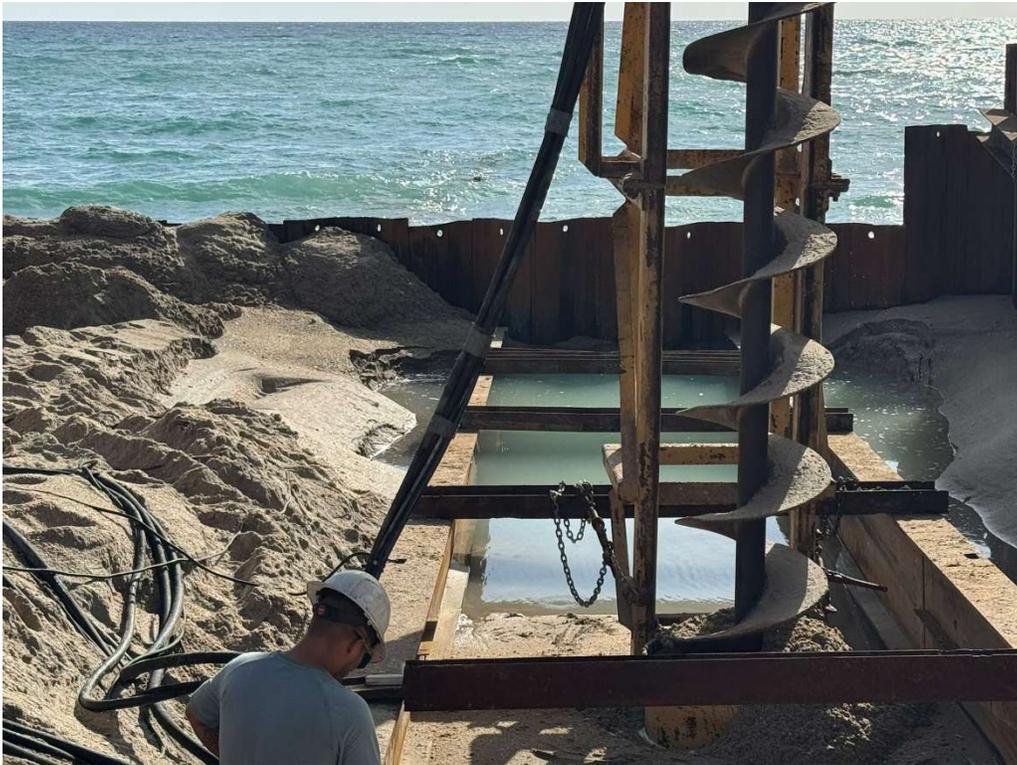
Cofferdam at Groin A implemented

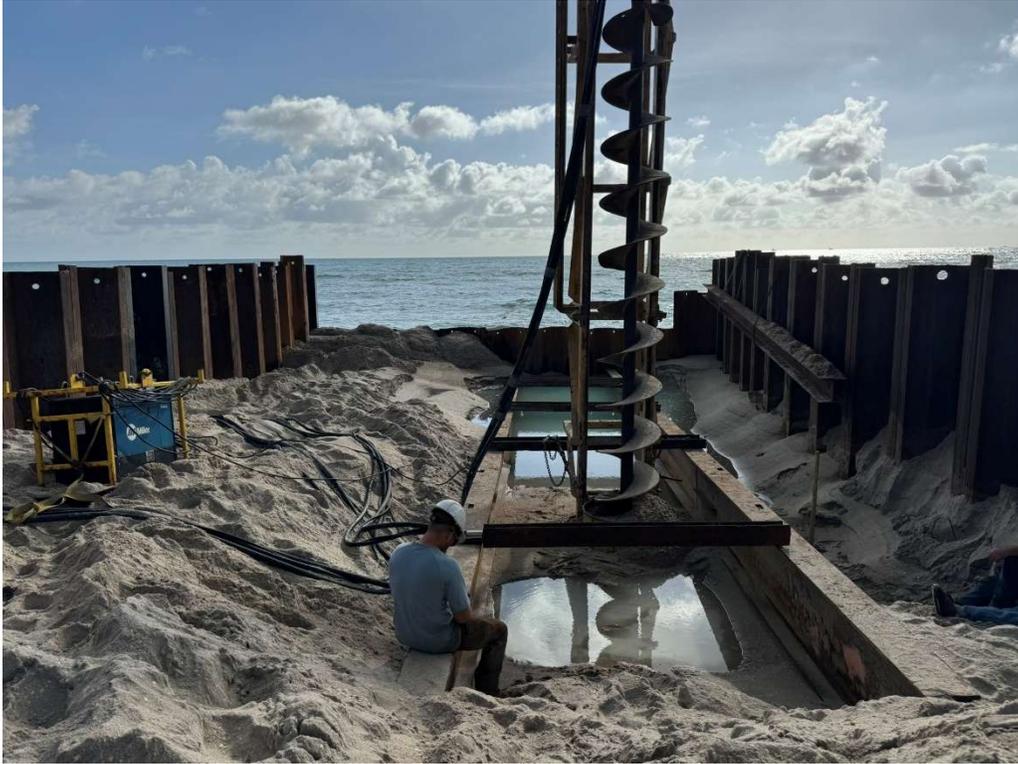
Augering at Groin A

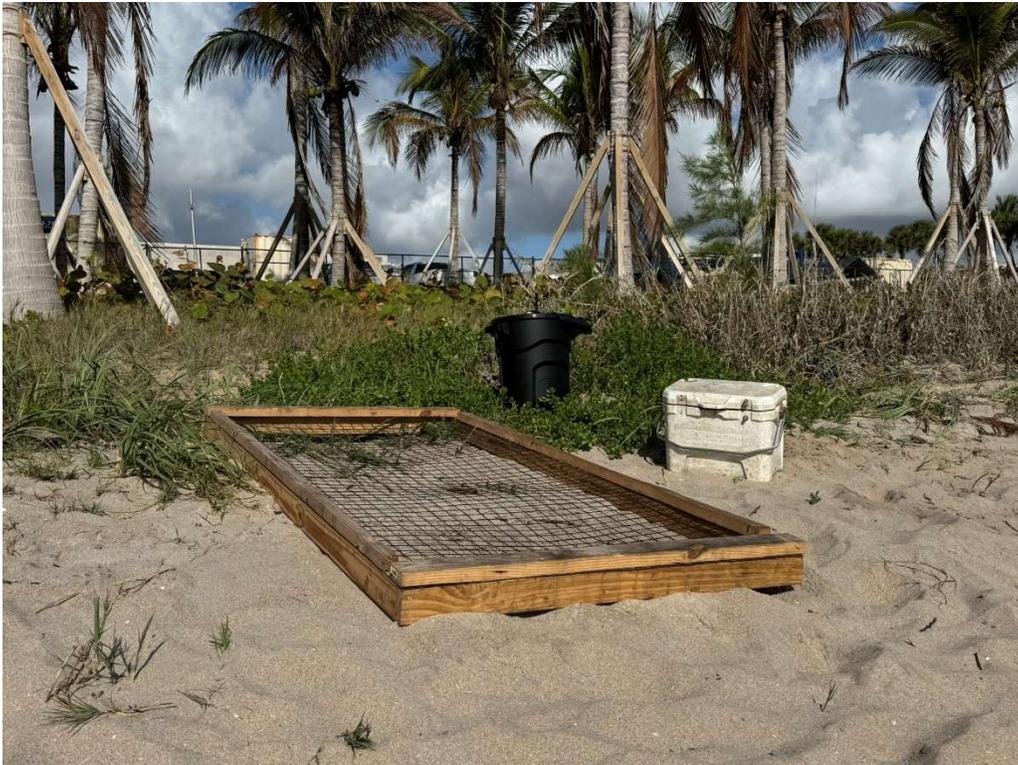
Mesh screening for construction debris

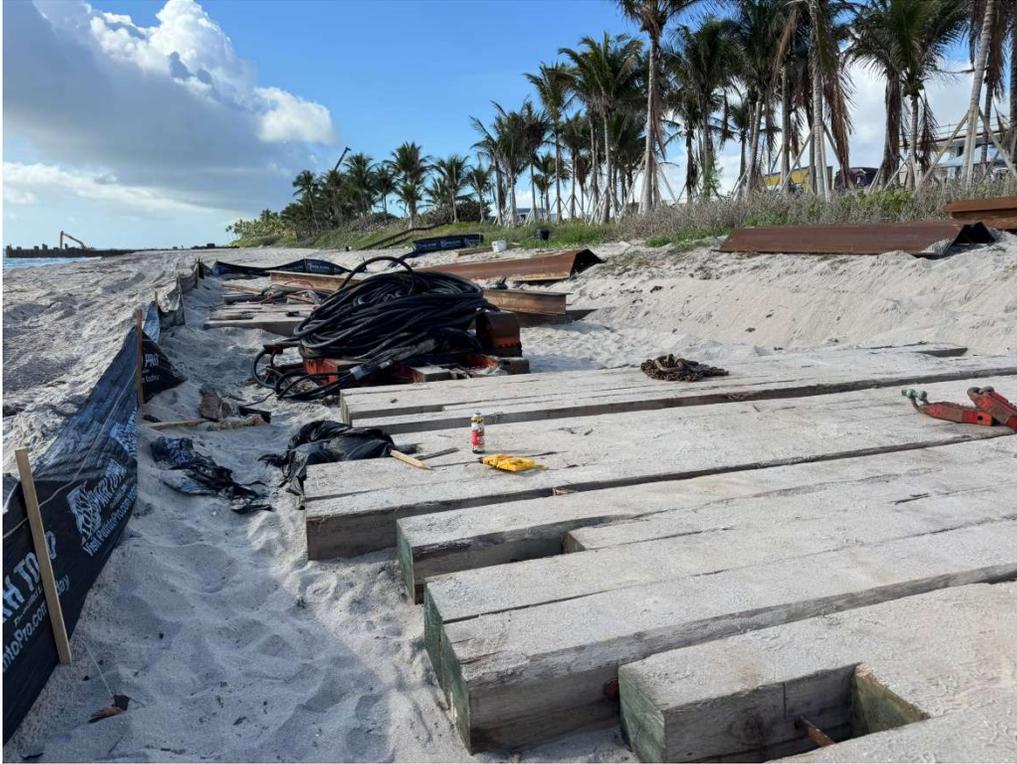
Current site conditions at Groin A

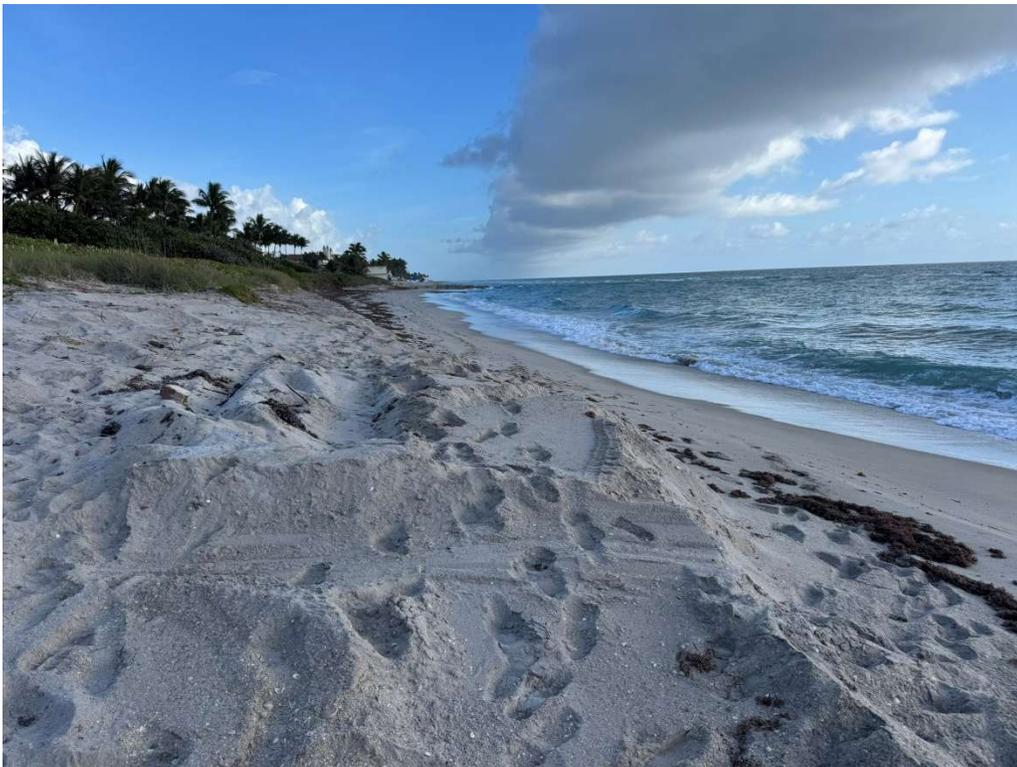
Beach property north of Groin A
