2026 Blossom Way Groin Rehabilitation Project

Engineer Observation Report

Date: 03/06/2026

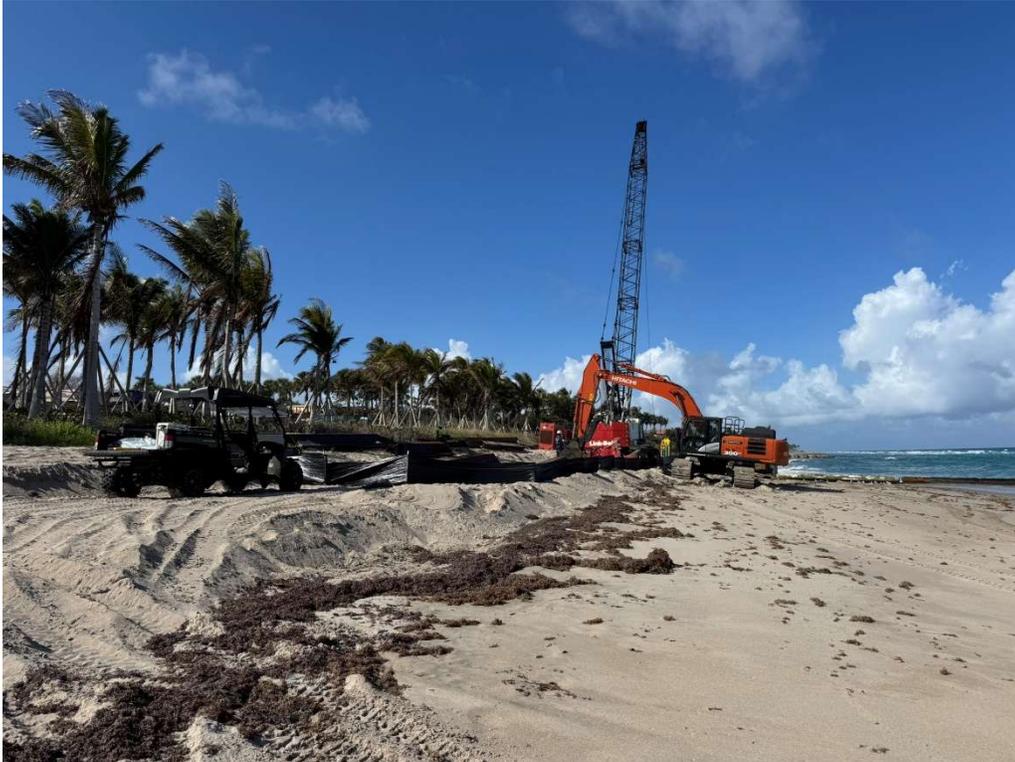
Spoke to Whitmore Benoit (Vance Project Manager) on site and updated me on the status of the groin rehabilitation. D19 – D4 have been placed at their respective elevation. They need to auger D3 – D1 for placement of H-piles. Crew has set up the construction site by groin A and started demolition of the concrete portion of the groin. 4-8 of the cofferdam panels have been installed around groin A.

Groin A construction site

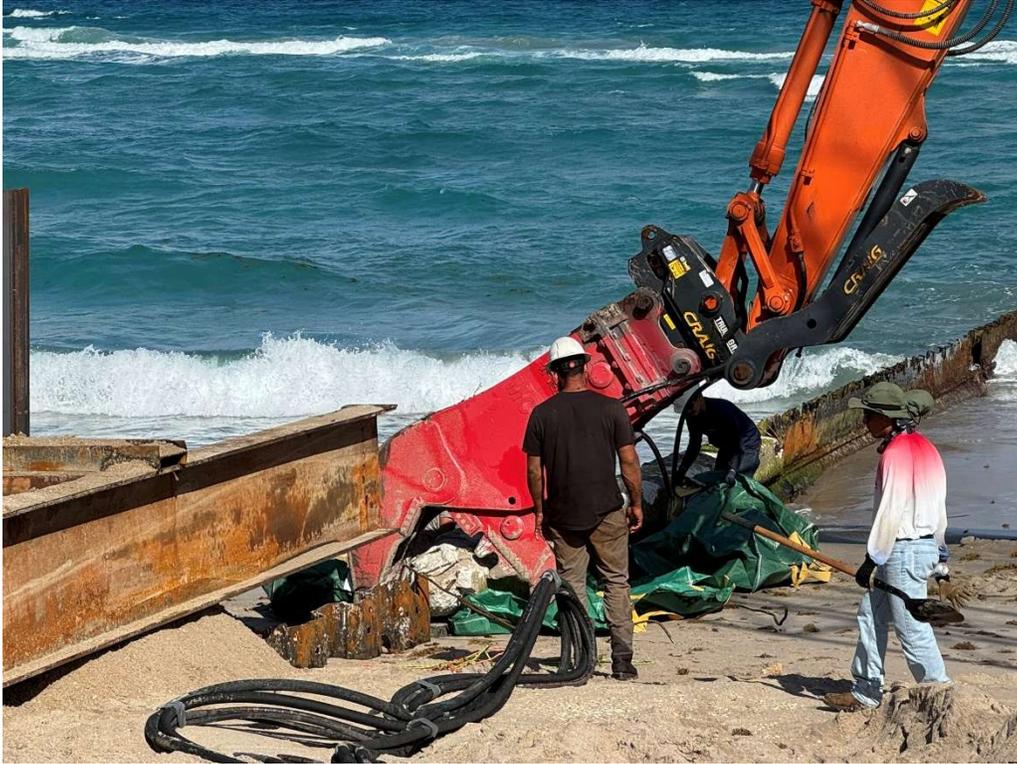
Crew has started demolition of Groin A while an excavator being used to install panels between the H-piles that have been set to elevation. Excavator being used to break apart the concrete part of groin A. Concrete bags used to transport the concrete rubble offsite. Cofferdam setup has started by implementing panels landward of the groin.

Demolition of concrete portion of Groin A

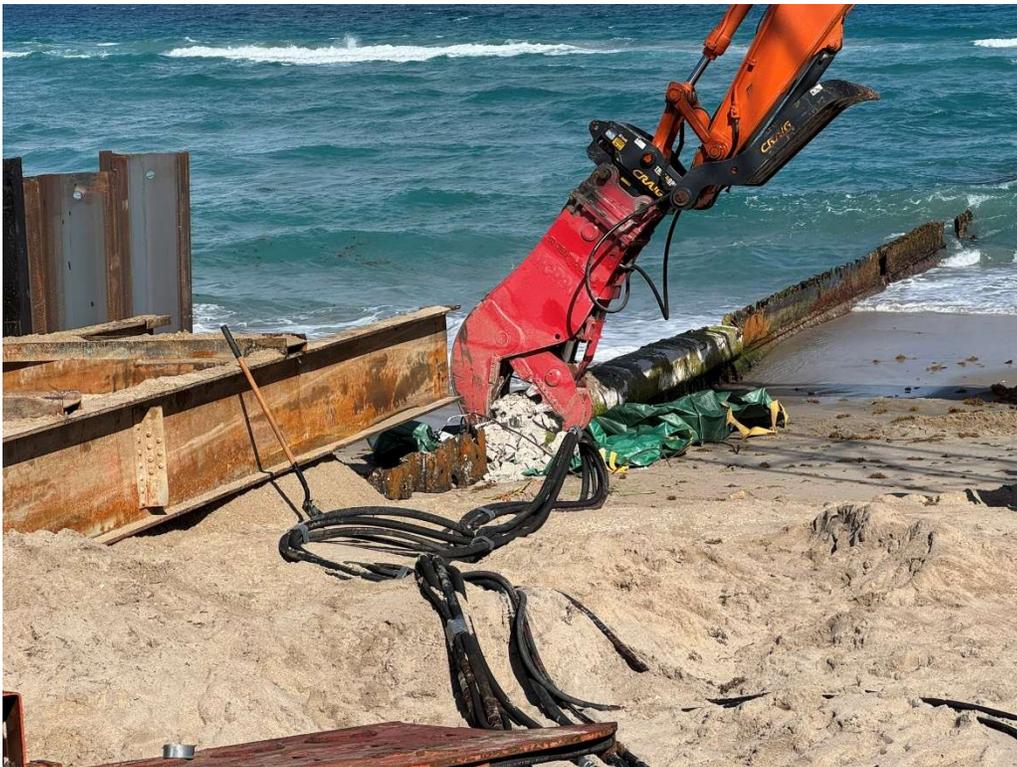
Use of green concrete bags to transport rubble off site

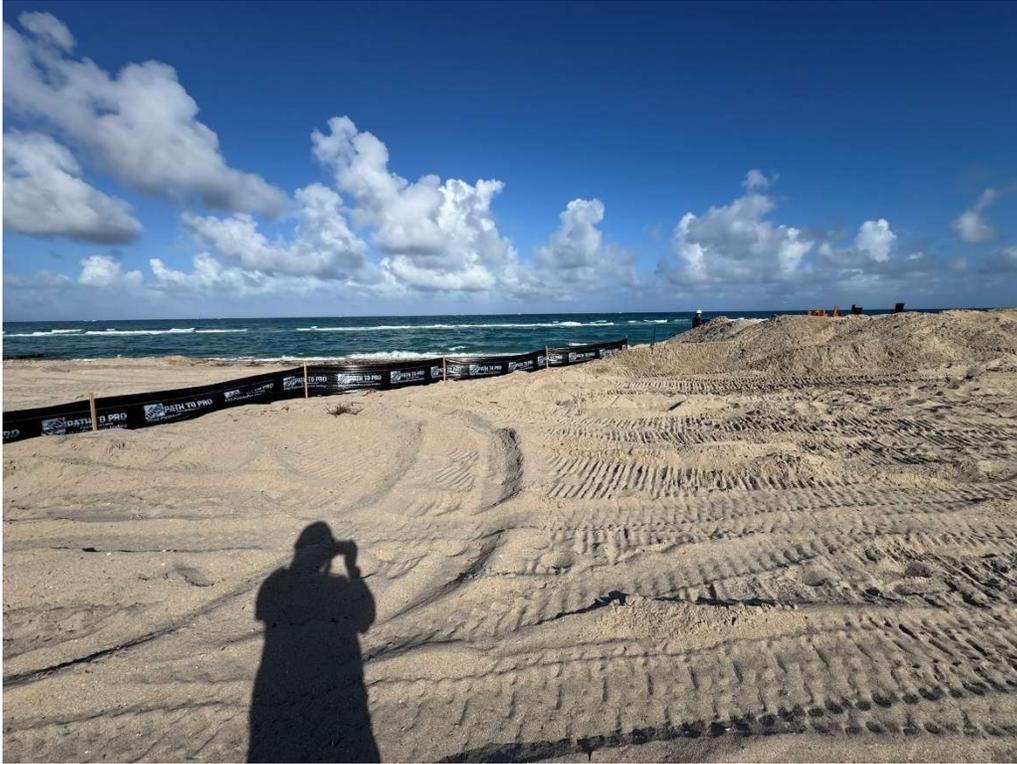
Attempted to auger D3-D1 but was unable to auger the holes. Panels that will be implemented between h-piles on groin D are located onsite within construction zones. Stake silt fence installed to block off construction zones from people and marine life.

Stake silt fence implemented for construction boundary

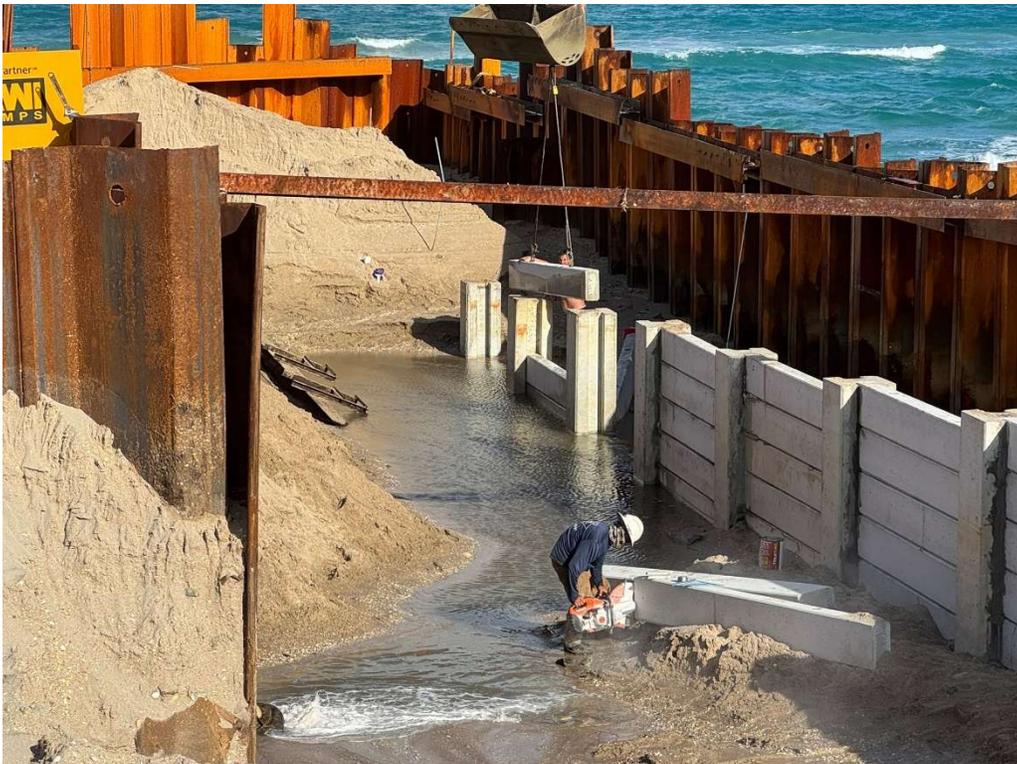
D4 – D19 have been placed in their respective locations and have been driven within 6-9 inches of elevation. Crew has broken off to start demolition of Groin A. Crew has started installing panels between h-piles.

Implementation of panels between H-piles on Groin D

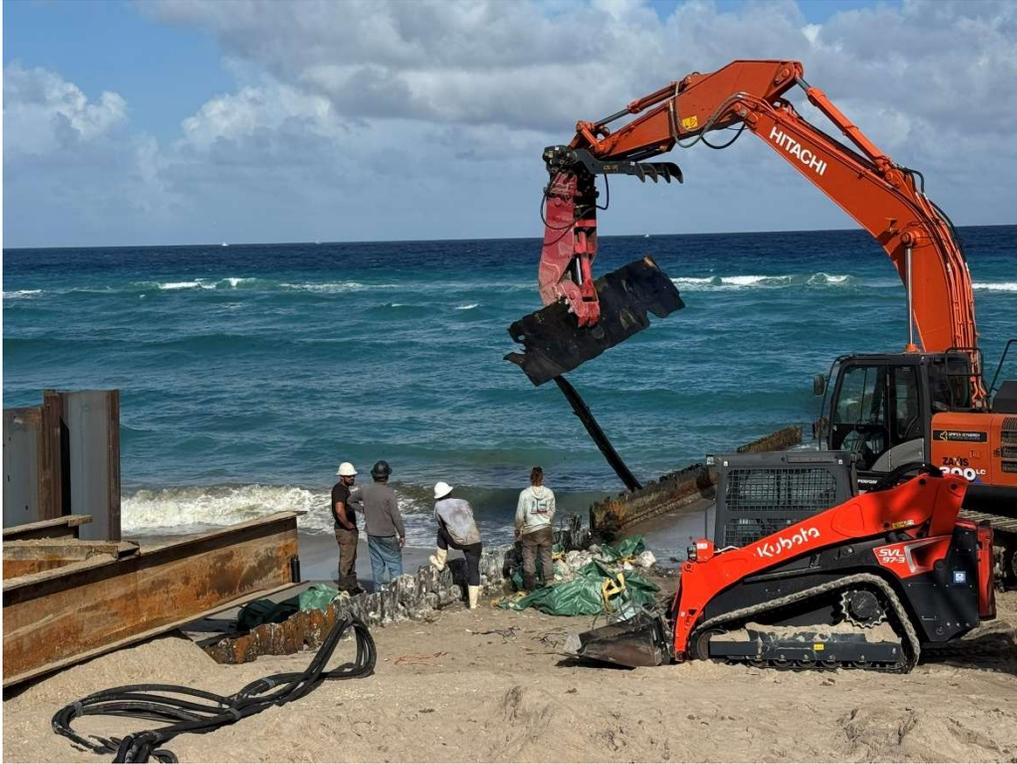
Partial removal of existing Groin A

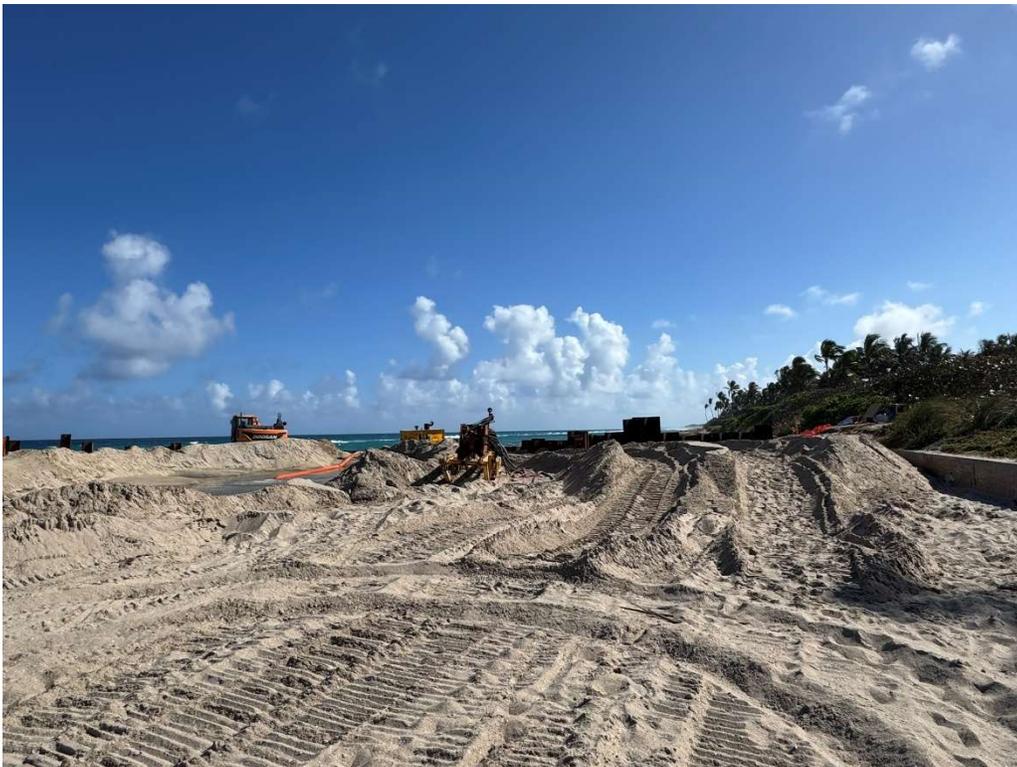
A ramp has been provided for the turtle monitors to use for monitoring the beach for turtle activity.

Turtle monitoring ramp

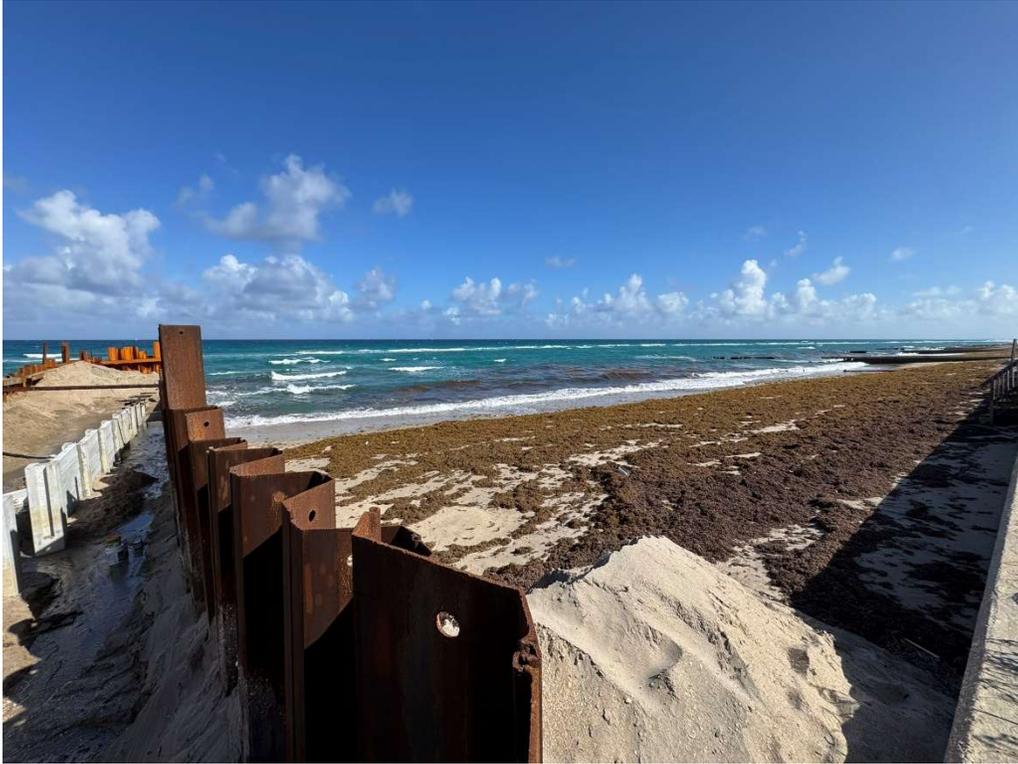
Downdrift beach of Groin D

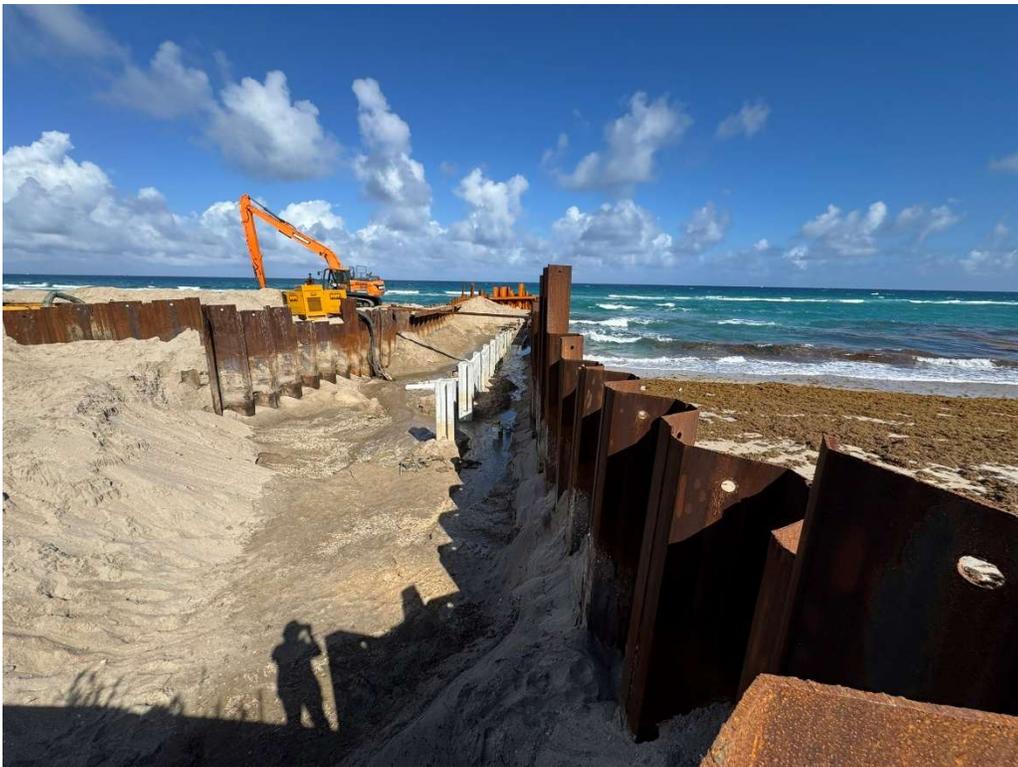
Groin D cofferdam conditions
