A RESOLUTION OF THE TOWN COUNCIL OF THE TOWN OF PALM BEACH, PALM BEACH COUNTY, FLORIDA, RECEIVING AND ACCEPTING THE COMPREHENSIVE COASTAL MANAGEMENT PLAN, DATED AUGUST 1986, AS PREPARED WITH THE PROFESSIONAL AND TECHNICAL ASSISTANCE OF THE COASTAL ENGINEERING CONSULTANT, CUBIT ENGINEERING LIMITED.

COMPREHENSIVE COASTAL MANAGEMENT PLAN FOR TOWN OF PALM BEACH

CUBIT ENGINEERING LIMITED

AUGUST 1986

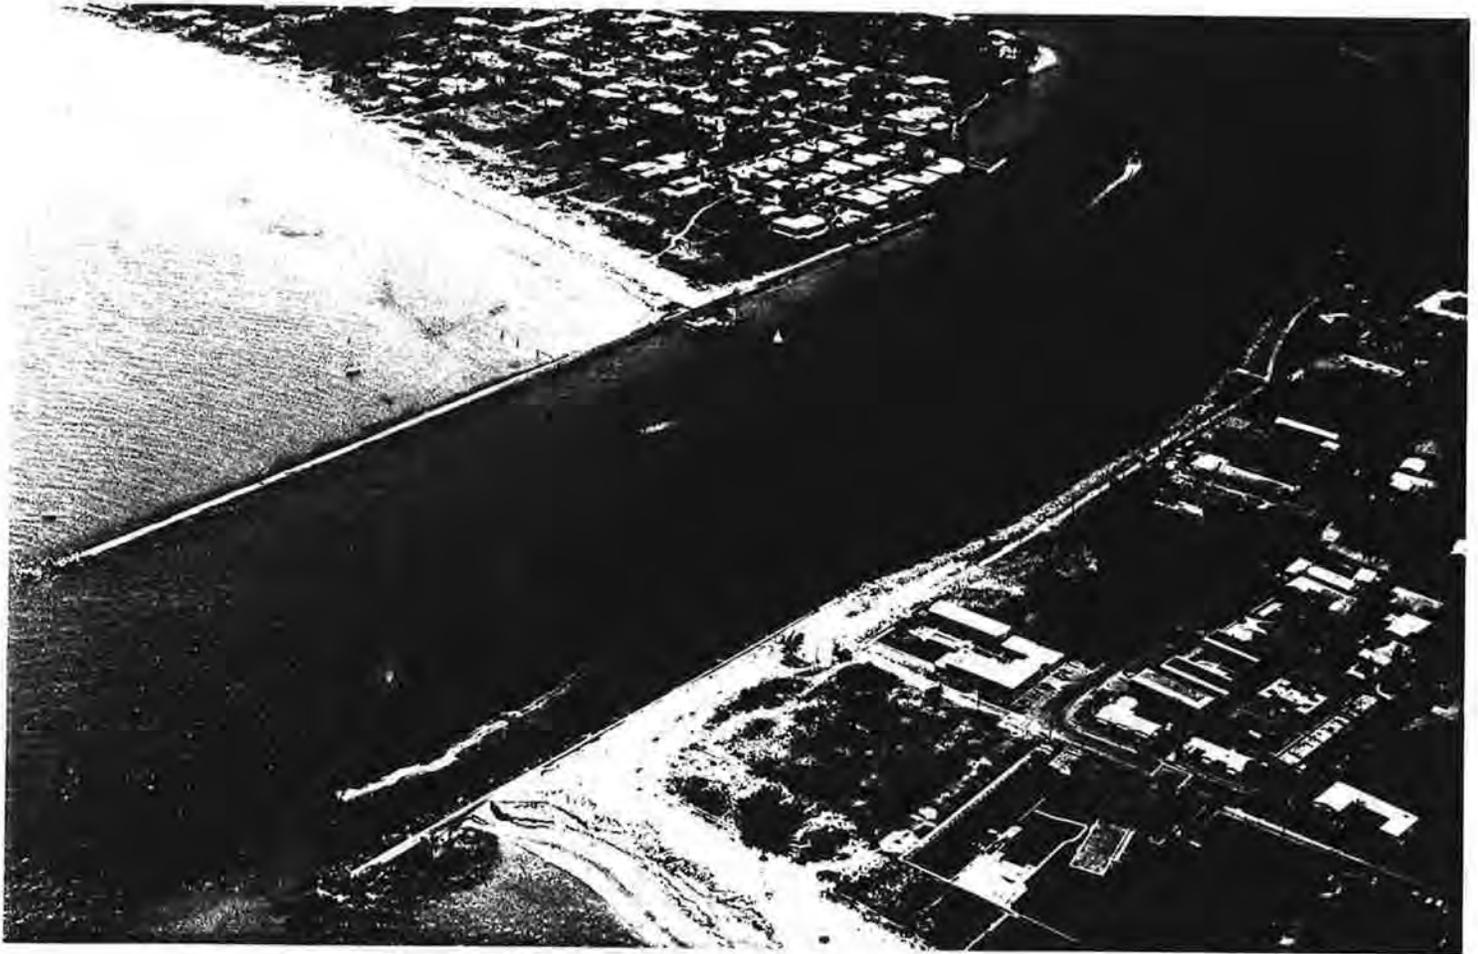
FIGURE 5.1 AERIAL VIEW OF LAKE WORTH INLET

MAY 1985

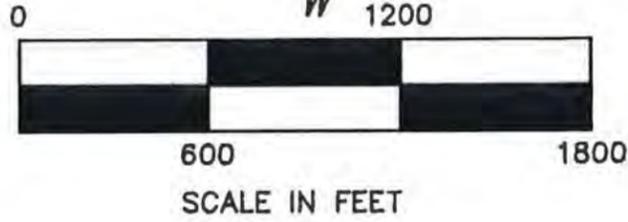
FIGURE C.1

PLAN SUMMARY

- 1) MAINTAIN SEAWALLS AND GROINS
- 2) MODIFY GROINS 27N TO 15N IN THE FUTURE TO ALLOW PASSAGE OF SAND EQUAL TO THAT BYPASSED AROUND THE LAKE WORTH INLET
- 3) MONITOR BEACH

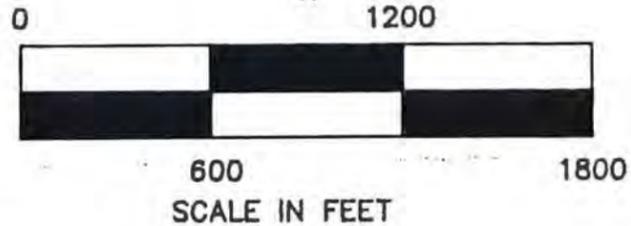
FIGURE C.6

PLAN SUMMARY

- 1) ENDORSE FEDERAL PROJECT AT LAKE WORTH MUNICIPAL BEACH FRONT PARK
- 2) MONITOR BEACH
